## OPERATION SUMMARY INSPECTION REPORT

Well/Facility Name:	Cameron Hills H-03 Battery – H-58/D-49/N-28/I-16/ M-73/2M-73/C-74/H-03 Flaring Facility	Operator:	Strategic Oil and Gas Ltd.
Location of Inspection:	Cameron Hills – South Slave Administrative Region	Access method:	Winter Road access from Alberta Highway 35, 1km South of Indian Cabins, AB.
Site Contractor:	Global Well Services/Pinnacle Industrial Services/Dragons Breath Production Services/Spectrum Wireline Services	Status:	Suspension and Abandonment Operations
Approval Info	OA-1237-01 ACW-2018-004	WID:	1975/1973/1753/1482/1765/2026/1939
Date of Inspection	February 4 & 5, 2019	H2S Site:	Yes

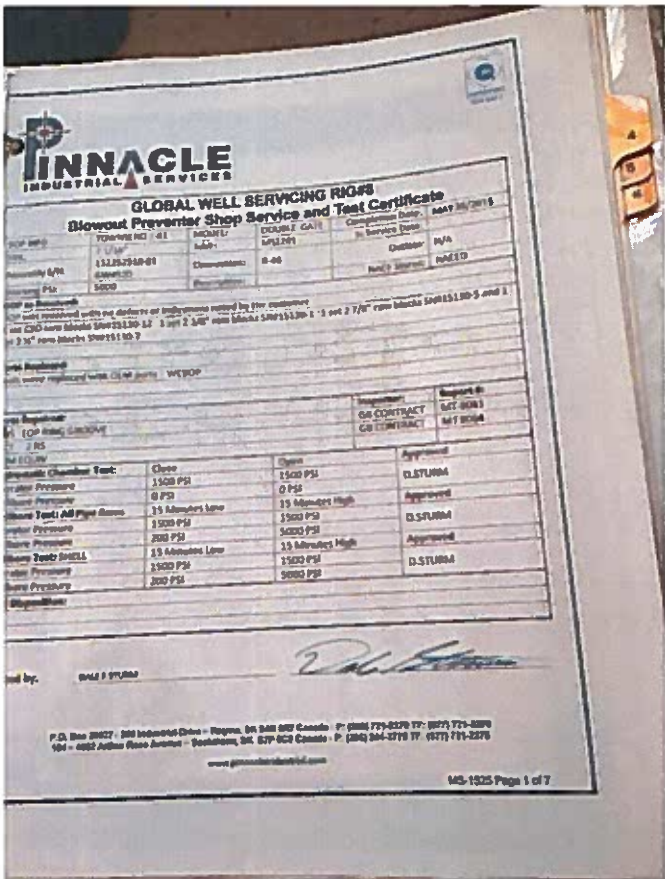
Conditions	Satisfactory (Y/N)	Comments
<b>Rig Safety</b>		
Accumulator function test	N/A	<b>February 5, 2019 - 12 22h:</b> During the inspection of the C-74 well site, the BOP was not installed on the well at the time of inspection thus a full function test could not be conducted. A sizing calculation was conducted that confirmed the system has enough volume to function BOPs.
Equipment Certifications	Y <sup>1</sup>	<p><b>February 5, 2019 - 12 00h:</b> While inspecting the equipment at the C-74 well site, the provided certifications on site did not match the equipment that was present. However, the certifications provided as part of the ACW application did match the equipment. (See Photo # 1)</p> <p><sup>1</sup><b>Required Action:</b> The OROGO Compliance Team provided the rig manager with the correct certifications for their records. All certifications need to be reviewed to ensure they are up to date and match the equipment being used on site.</p>

Photo # 1: Improper BOP certification for the equipment on site.

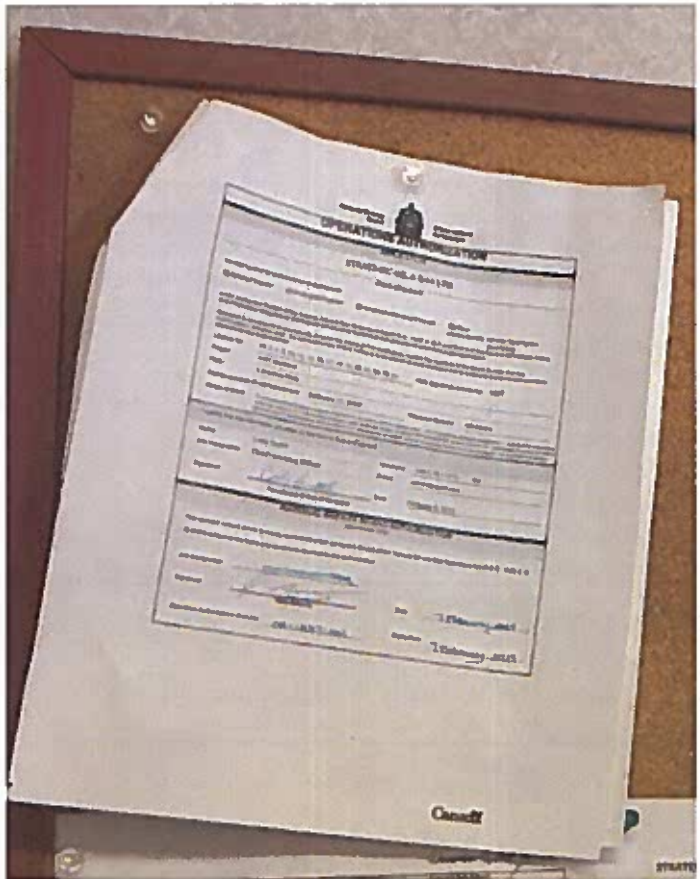
Approvals available	N	<p><b>February 4 &amp; 5, 2019:</b> Incomplete Authorization Approvals were posted in the dog house at the C-74 well site as well as the H-03 Battery Camp.</p> <p><b>Required Action:</b> The Operations authorization does not have the amendments issued by OROGO on August 3, 2017. These amendments need to be attached to the current authorization at all locations on site. (See Photo# 2)</p>
Boiler Inspection	Y	
Guards and covers on moving equipment	Y	
Pump lines and hoses	Y <sup>2</sup>	<p><b>February 5, 2019:</b> A fire rated hydraulic line attached to the annular preventor had a separation in the fire resistant sheathing and required replacement.</p> <p><sup>2</sup><b>Note:</b> Site staff readily removed the hose from service and located a replacement for use while the OROGO Compliance Team was on site.</p>
General Housekeeping	N	<p><b>February 5, 2019:</b> The area in and around the accumulator was being used as storage which made access to the accumulator a challenge. The fashion in which these items are being stored being stored inhibited easy ingress and egress from the building as well as the ease of use of the secondary BOP controls.</p> <p><b>Required Action:</b> The accumulator trailer should be organized at all times to ensure unrestricted ingress and egress for the primary purposes of effective accumulator functions and inspection.</p>

Photo # 2: Copy of the Operations Authorization that does not contain the amendments issued by OROGO on August 3, 2017.

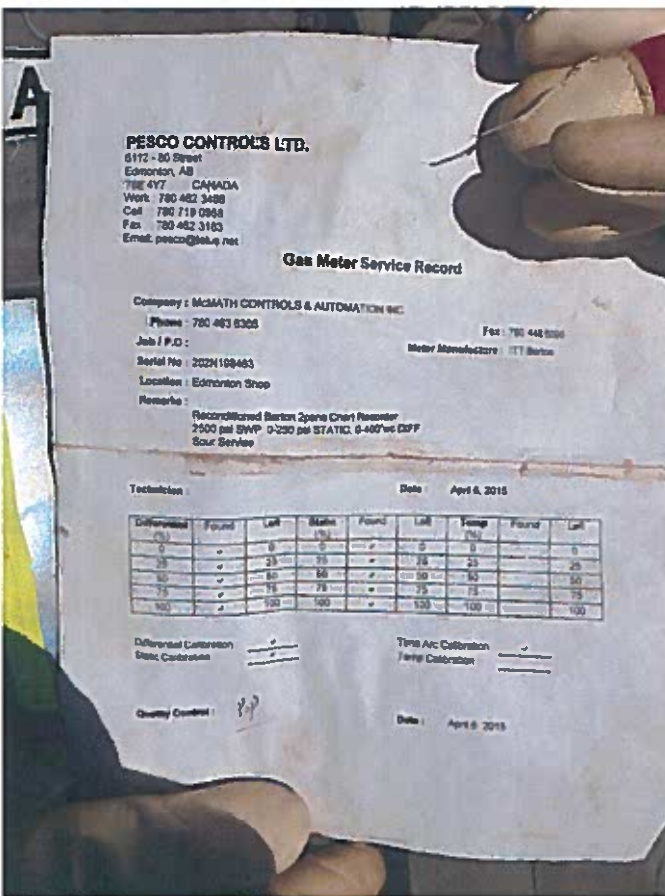
Adequate lighting in each work space	Y	
Wind indicators visible	Y	
Fire extinguishers	Y	<b>February 4 &amp; 5, 2019:</b> All inspected fire extinguishers had been recently inspected to ensure they could be in service.
Other	N	<p><b>February 5, 2019:</b> The records for gas meter at the pressure tank connected to the flare stack located at the C-74 Well Site indicated it had not been calibrated since April 2015. (See Photo #3)</p> <p><b>Required Action:</b> Requirements for meter calibration frequency need to be confirmed with the onsite contractor. Should calibration be required since 2015, it will need to be conducted.</p>
<b>Personnel Safety</b>		
Valid safety tickets: FA-CPR/H2S/WHMIS/TDG	Y	
Safety meetings and documentation	Y

Photo # 3: Gas meter calibration log at C-74 pressure tank.

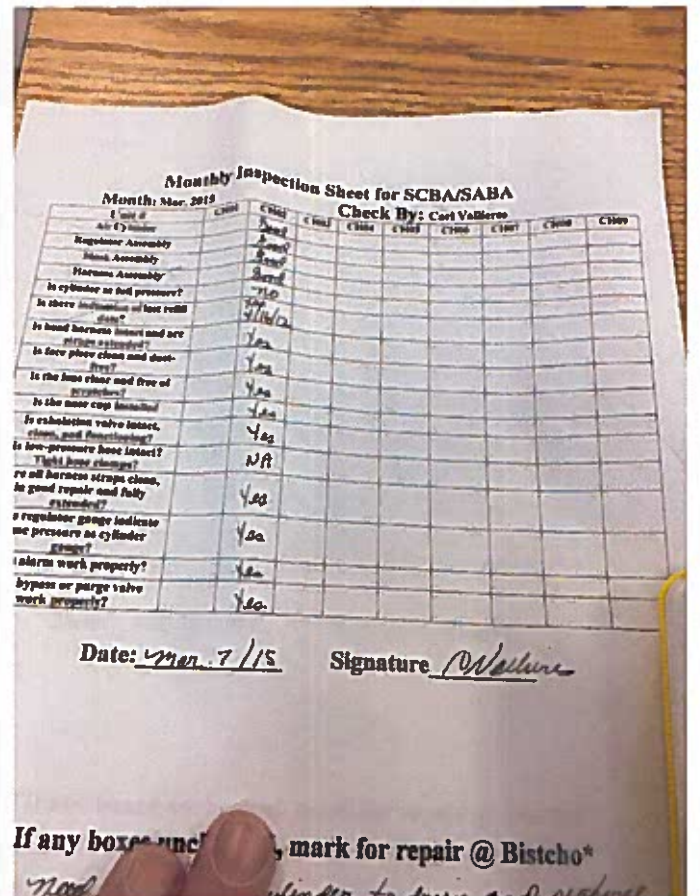
SCBAs available and visible	N	<p><b>February 5, 2019:</b> Upon review of the inspection records of the two SCBA units (CH-01 and CH 02) at the H-03 Battery Camp, it was not readily apparent that these units had been checked to ensure proper operation since 2015 (See Photo# 4). Upon further review, a hand written note was found on the back of the inspection sheet indicating an inspection in December 2018 that identified there was no low level alarm on CH-02. (See Photo# 5) No record of a repair could be found.</p> <p><b>Required Action:</b> SCBA units are a vital piece of safety equipment that need to be inspected to ensure they are functioning appropriately. Strategic Oil and Gas Ltd. is required to ensure that all SCBA units are inspected and suitable for use in the event of an emergency. Inspection and repair forms are required to be properly completed for each unit.</p>
First Aid equipment and EMS	Y

Photo # 4: SCBA inspection sheet for units CH-01 and CH-02

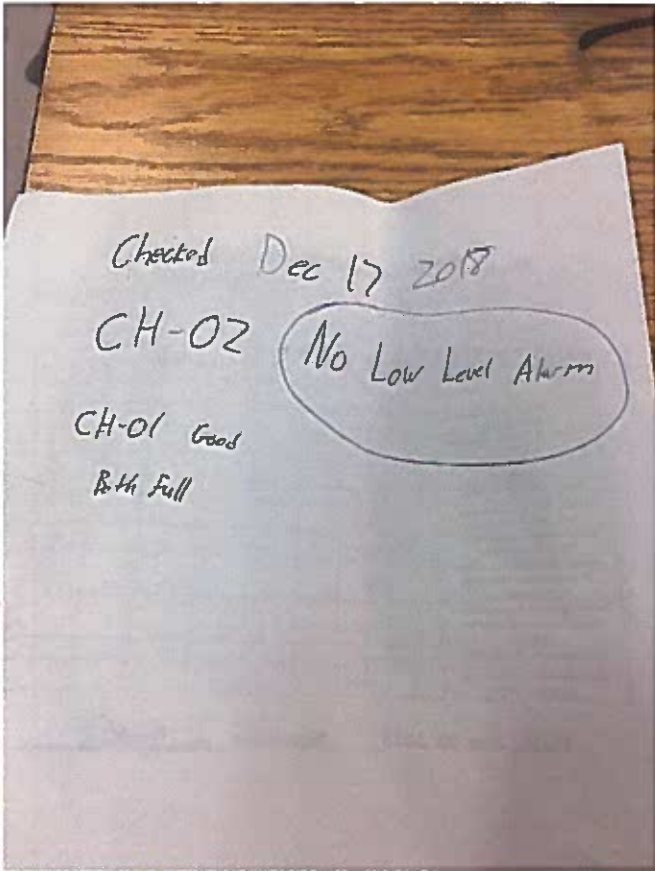
**Photo # 5:** Hand written note for December 2018 inspection of SCBA units CH-01 and CH-02.

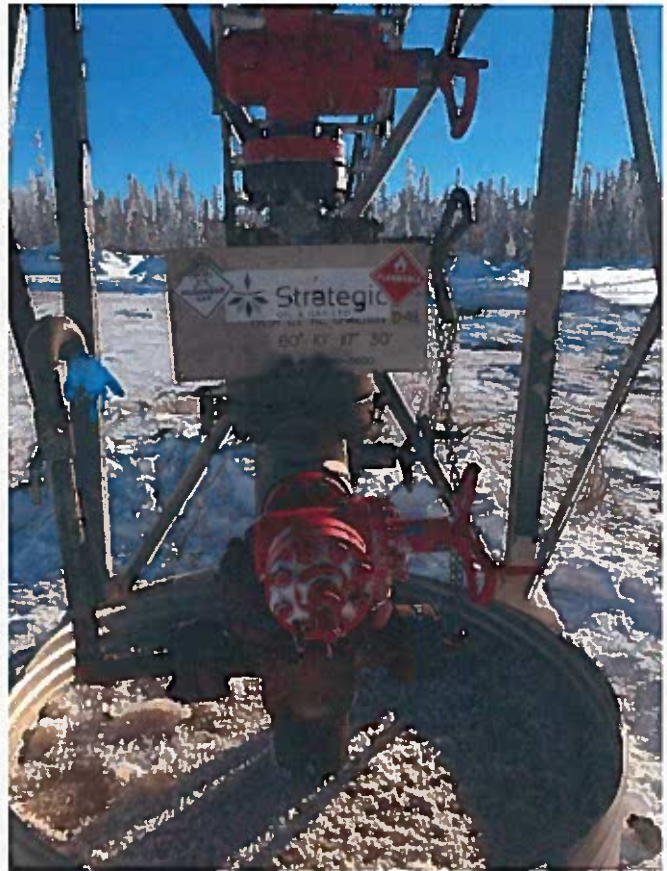
Gas detection equipment	Y	<b>February 4 &amp; 5, 2019:</b> All staff was wearing a 4 head personal gas monitor.
Communication plans	Y	
Hazard identification and signage	N	<p><b>February 5, 2019:</b> Well sites H-58 and D-49 had signage posted that listed Paramount Resources Ltd. phone number to call in the event of an emergency. (See Photo # 6)</p> <p><b>NOTE:</b> All signage on site with Paramount Resources Ltd. 24 hour emergency line will need to be updated to the Strategic Oil and Gas Ltd. 24 hour emergency number.</p>
ERP, Safety Plan available upon request	Y	These plans were available in the dog house as well as the H-03 Battery Camp.
Other	N/A	
<b>Blowout Prevention Equipment</b>		
BOP Certifications	Y <sup>3</sup>	<p><b>February 5, 2019 - 12 00h :</b> While inspecting the equipment at the C-74 well site, the provided certifications on site did not match the equipment that was present. However, the certifications provided as part of the ACW application did match the equipment. (See Photo # 1)</p> <p><b><sup>3</sup>Required Action:</b> The OROGO Compliance Team provided the rig manager with the correct certifications for their records. All certifications need to be reviewed to ensure they are up to date and match the equipment being used on site.</p>

**Photo # 6:** Improper emergency response number posted

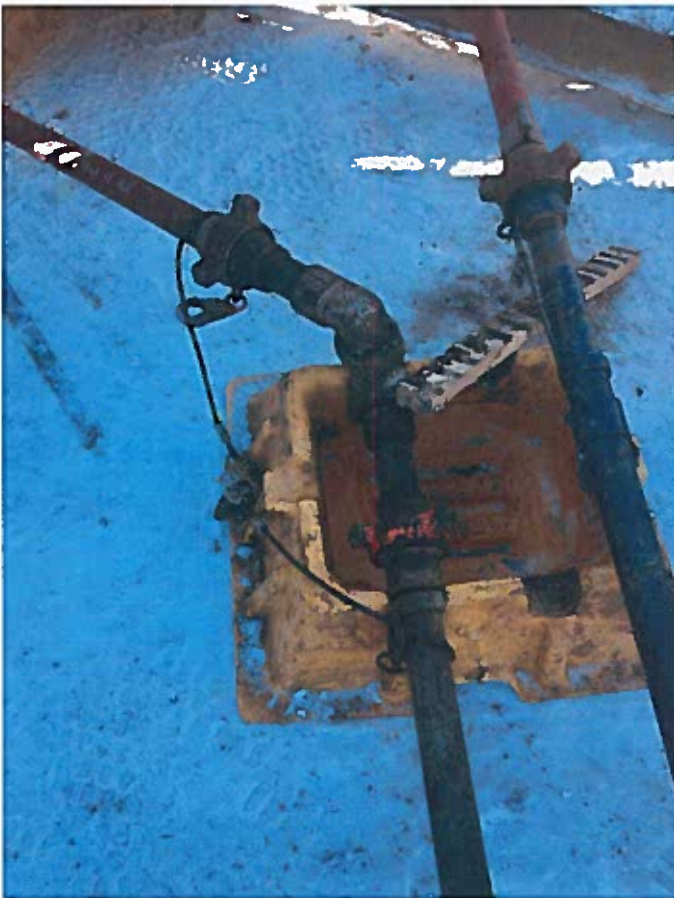
**Photo # 7:** Flow lines secured.

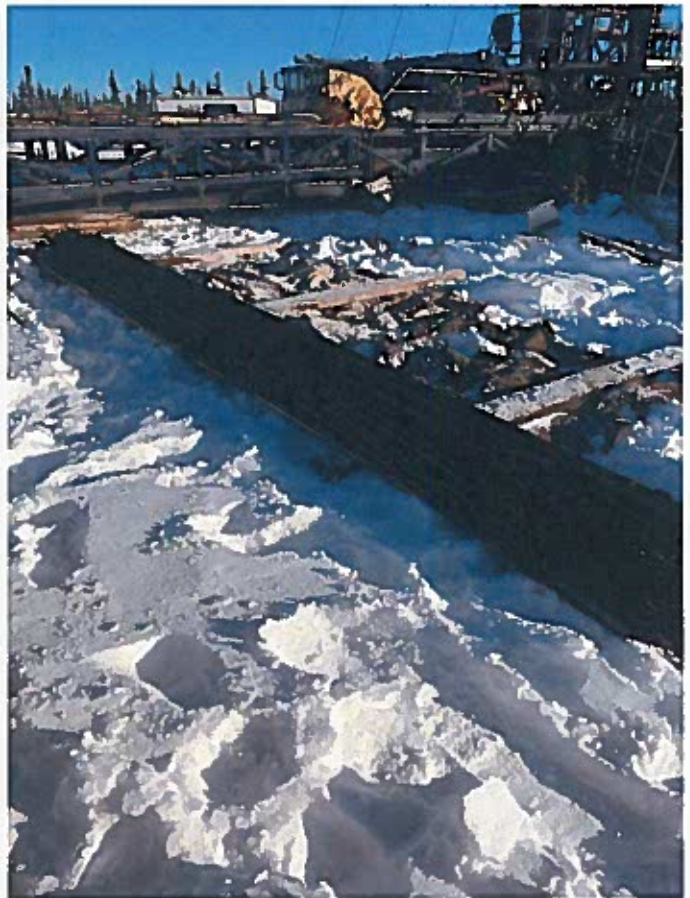
**Photo # 8:** Improper containment of rods that could lead to a discharge of a contaminant.

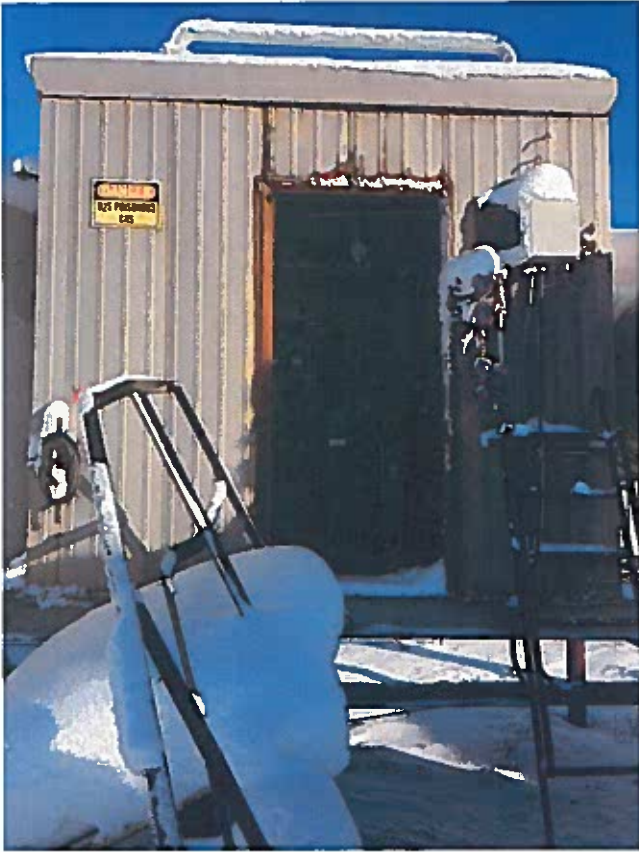
It was noted that the conditions of the separator buildings at most of the inspected well sites were in various states of disrepair. This ranged from corrosion of infrastructure and gauges inside the separator buildings, unsafe entrance stairs and corroded doors frames that would not support the installation of a door. (See Photo # 9) Mitigation measures should be put in place to ensure that site staff is aware of the unsafe nature of these buildings and that ingress and egress maybe impaired.

**Photo # 9: H-58 separator building.**
