Jean Marie River Well Inspections

Jean Marie River, NT, July 21-23, 2014

The Office of the Regulator of Oil and Gas Operations

December 4, 2014

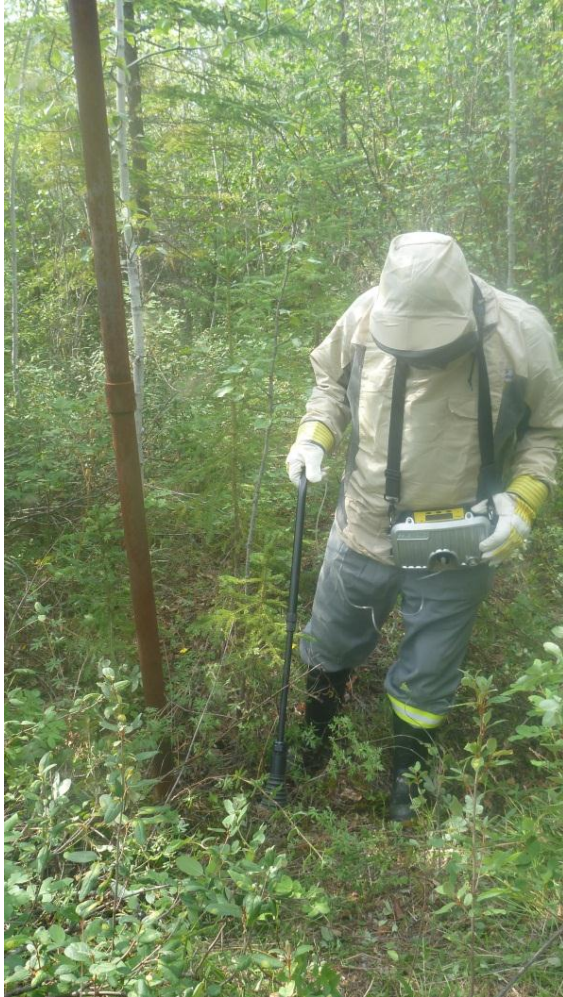
Photo 3: Jean Marie J-52 Well

The well is surrounded with secondary growth and located on solid ground (approximately 25m radius). Beyond the well site is muskeg and dense vegetation. The well site was located by local guide (Mr. Ernest Hardisty). The site was situated on solid ground at the edge of a muskeg clearing. The well was marked with a 2.5m steel pipe (5cm diameter) welded to the cap. The well site can be seen in photo 3, with additional photos in Appendix B.

Monitoring was conducted using a Portable Methane Detection unit (PMD). The ground surface was tested using the PMD wand, no methane was detected within proximity of the

wellbore. The soil was also tested for methane using monitoring cups⁵ in several locations surrounding the casing. No evidence of methane was present.

A visual inspection showed signs of healthy vegetation in all surrounding areas. There was no apparent evidence of vegetation stress. A 0.75m section of hydraulic hose was discovered approximately 15m from the well site (photos in Appendix B).

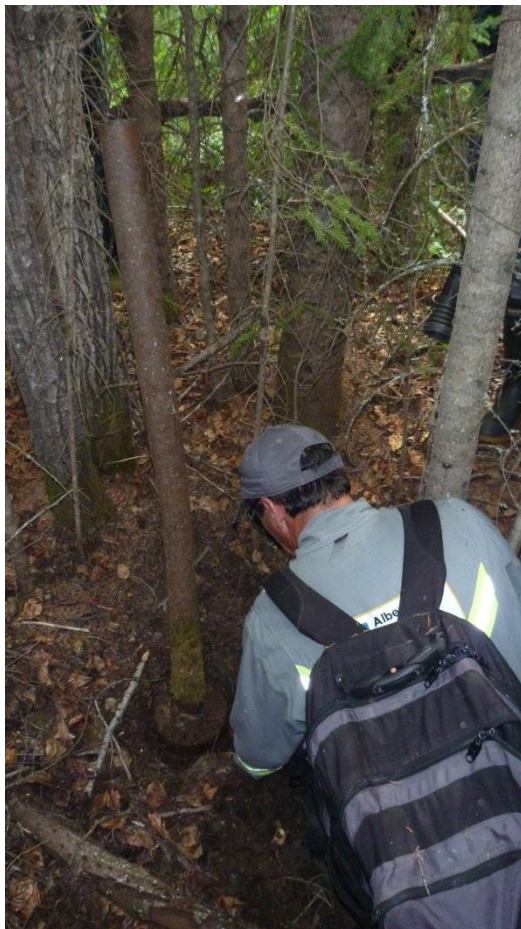
Photo 5: Jean Marie Creek No.1 Well

With the help of local guide (Mr. Angus Sanguetz), the well was discovered amongst a clump of spruce trees. A 1m steel pipe (5cm diameter) was welded to the cap of the well. The rusted steel pipe proved to be very difficult to see between trees of similar

diameter as (see photo 5).

Methane detection was conducted using a Portable Methane Detection unit (PMD). The ground surface was tested using the PMD wand, no methane was detected within proximity of the wellbore. The soil was then tested using monitoring cups in several locations surrounding the casing. No evidence of methane was present. A visual observation of the surrounding site was conducted by the team members. There were no obvious signs of vegetation stress either in the trees or low-lying shrubs. There was no other evidence of drilling activity in the area such as a drilling sump or left over materials.

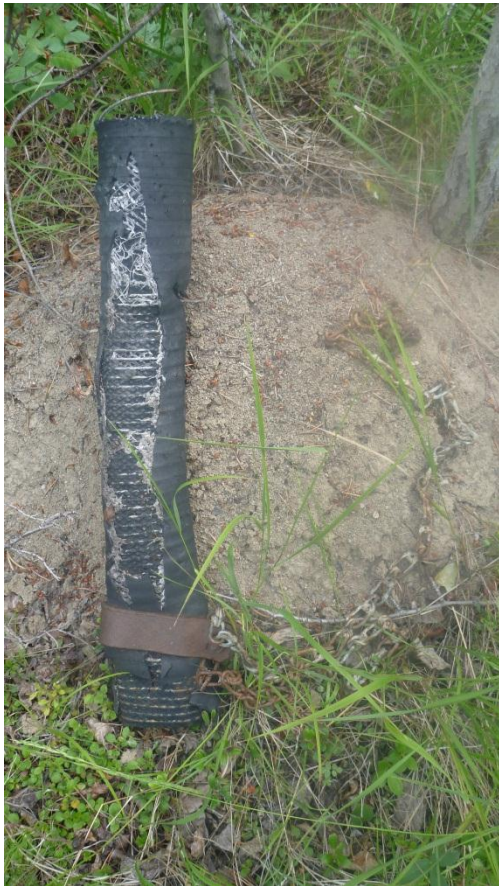
J52 Well: Hydraulic hose found near well

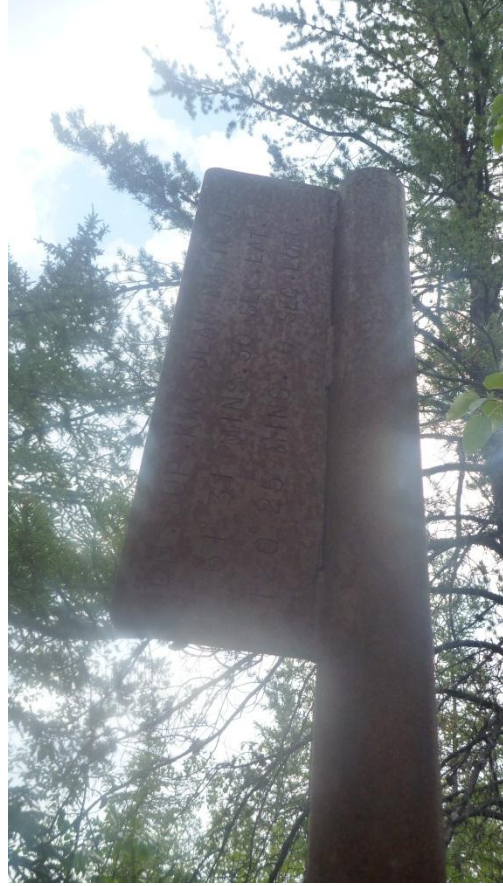
J52 Well: Wellhead marker pipe

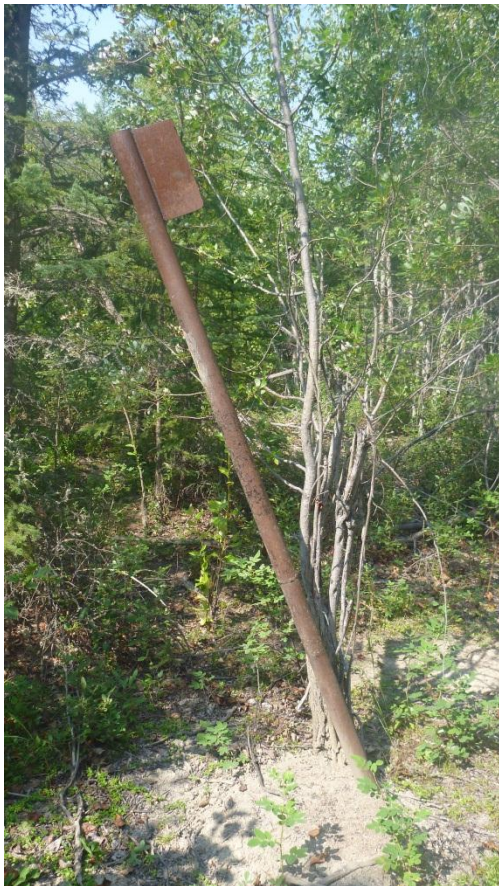
From the air, the well seemed to be located in a flat open area, however, at ground level, the area was vegetated with willows and smaller shrubbery. The well marker was discovered to be surrounded by a large ant hill. The 2m steel pipe identifying the well was at a slight angle (see photo 4).

be connected in a way that would allow gas to escape through the marker. It is curious as to where the gas in the steel pipe could be originating. Given the fact the marker pipe was at a slight angle, the pipe may have detached from the steel plate.

B-48 Well: Wellbore marker

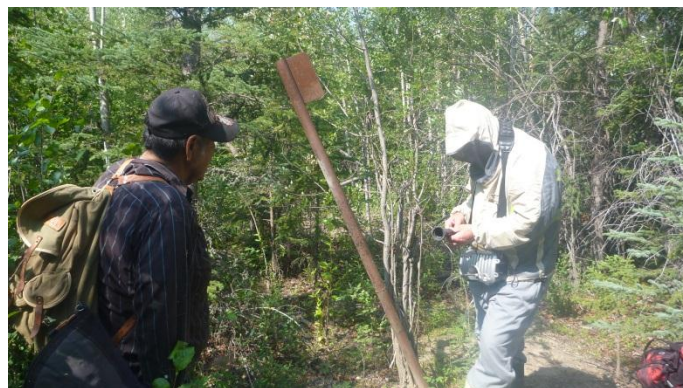
The wand was then held on top of the steel marker pipe and a peak reading of 500 ppm of methane was taken. To obtain a gas sample, the top of the pipe was taped shut for five minutes and a sample was then collected. A very small amount of gas was released when the tape was lifted, and the gas quickly dissipated. A forward looking infra-red (FLIR)⁶ camera was used to observe the gas exiting the pipe. The volume of gas released was extremely small, making it difficult to capture the release on the FLIR camera.

B48 Well: Methane monitoring

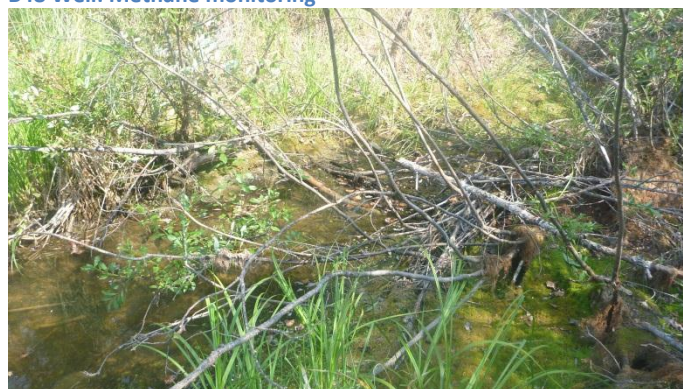
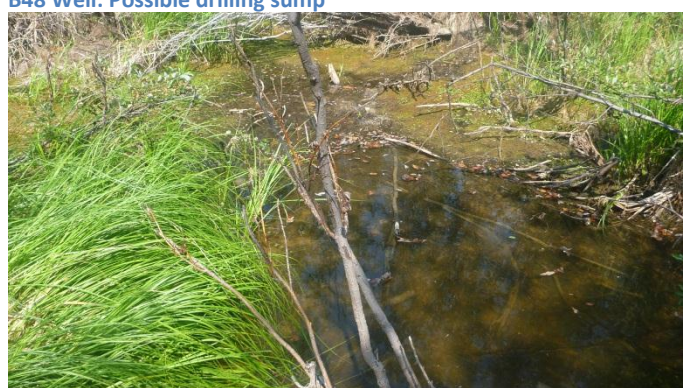
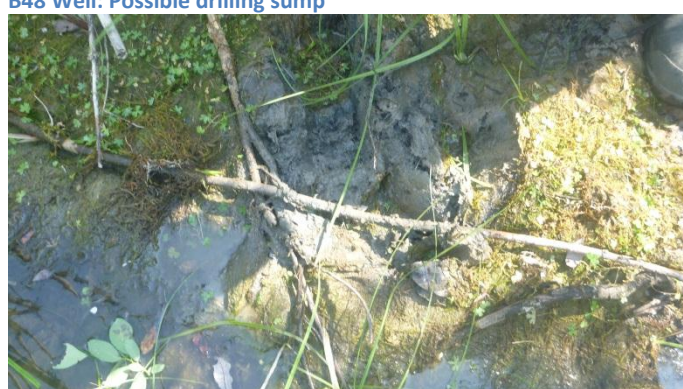
Aerial reconnaissance showed a low-lying area near the wellbore which could be the remnants of a drilling sump used when drilling the subject well. The low-lying area identified from the air, located approximately 15m from the well, was found to have abundant vegetation. There were no signs of hydrocarbons and no sheen present on the surface of the water.

B48 Well: Possible drilling sump

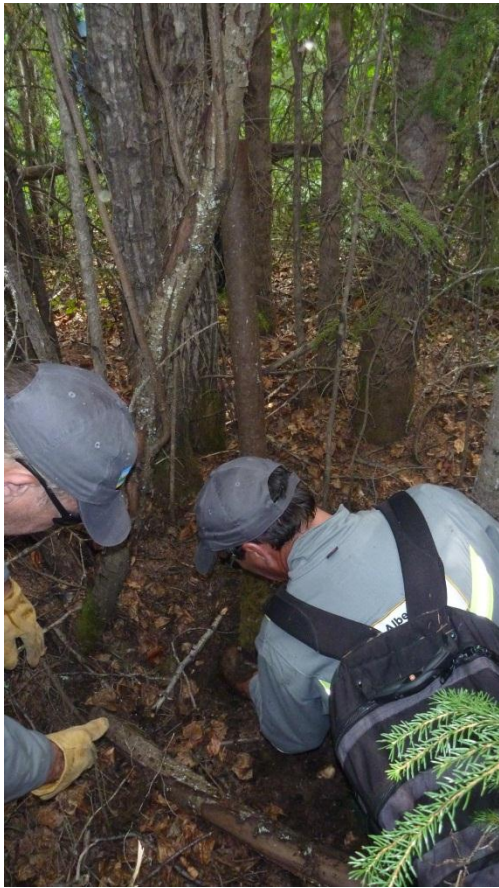
JMR No. 1 Well: Uncovering wellhead and cap

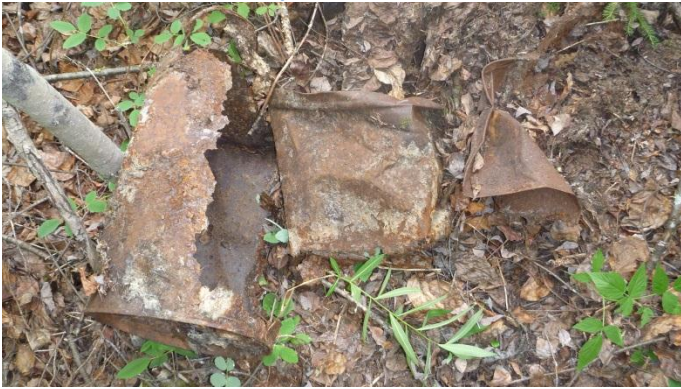
was tested using the PMD wand, no methane was detected within proximity of the wellbore. The soil was then tested using monitoring cups in several locations surrounding the casing. No evidence of methane was present. A visual inspection showed signs of healthy vegetation in all surrounding areas. There was no apparent evidence of vegetation stress. Some corroded metal cans were discovered 15m from the well site (photos in Appendix B).

Old rusted drums found near Westerosl 3A site

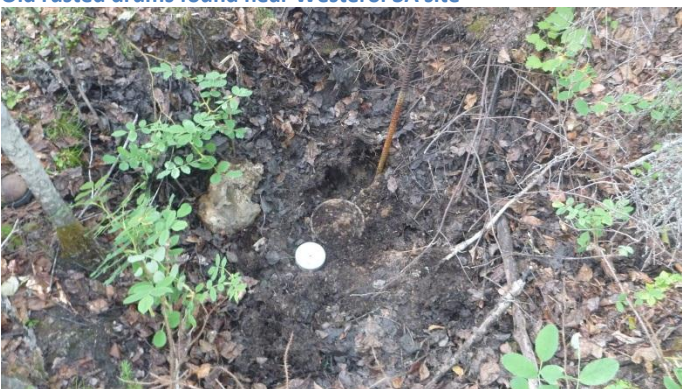
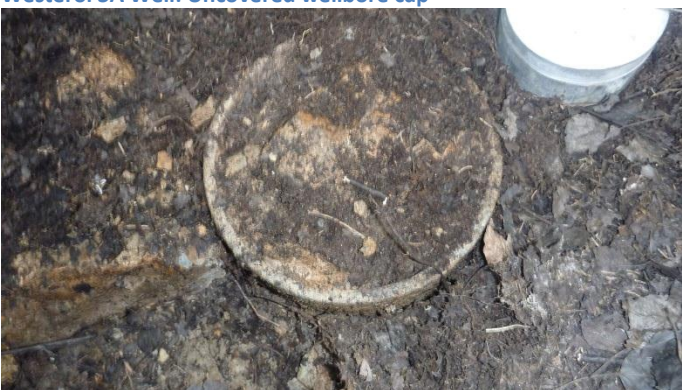
Westerol 3A Well: Uncovered wellbore cap

Westerol 3A Well: Unearthed wellbore cap
