**Devon Canada Corporation**

**Nahanni Butte Geologic Fieldwork Report**

**September 3 to 7<sup>th</sup>, 2003**

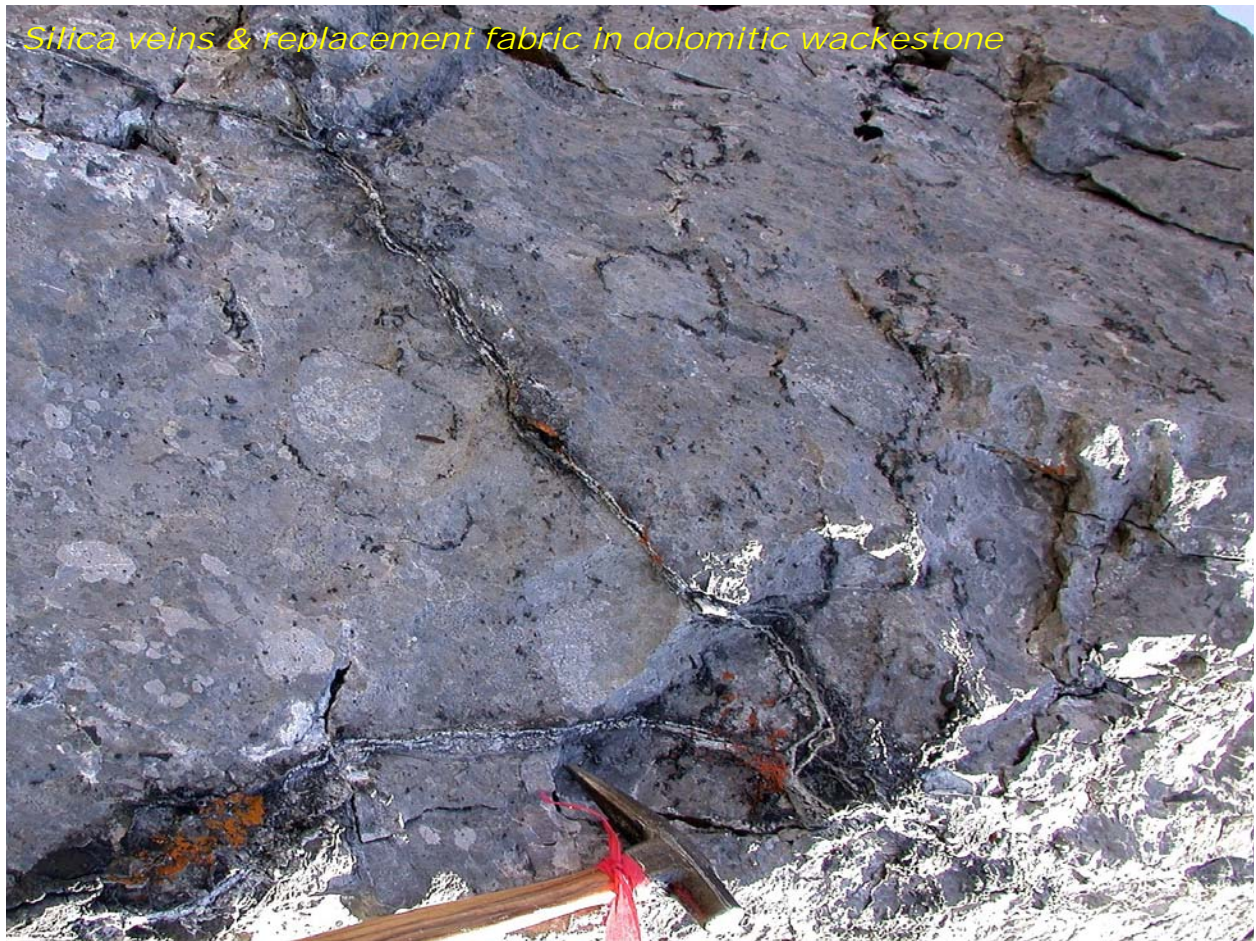
### NB SITE 4

Large “quarry” on slope below 3 above. Eastern edge contains 3-4m wide massive silica fault zone as above. **Silica highly fractured, with replacement of prior zebra dolomite texture in part.** Mineralized zone has Strike = 124d, Dip = 74dN. **Unmineralized fractures cut mineralized zone ~every 30cm,** with Strike = 45d, Dip = 66dSE. To far eastern edge of quarry (40m) shows quartz-filled fractures every 2-5m, with Strike = 110d, Dip = 85dS. **Within silica zone have incomplete silica occlusion and replacement of host rock, with scattered later dissolution. Huge vugs lined with silica & quartz, then dolomite. Partial to complete dolomitization of matrix in zone. Mottled dolomites mostly ~50% dolomite.** Large sinkhole at base of quarry. Silica rubble zone with unique, green-colored lichen 3-4m wide, the same as actual outcrop. 50m NW have ~2m wide silica zone as above. Massive vugs with silica rind, quartz and dolomite fillings. Blocks and smaller bits breaking off into the voids between silica veins. **1-2m away from silica ~50-60% dolomite in host rock. 0-50m NW small vertical fractures, horizontal dolomite in ~80% along solution vugs.** Appears like early stage zebra texture. 25m NW another 2-3m wide silica zone. At far NW edge of quarry a silica-filled fracture zone, 3-4' wide with Strike = 135d, Dip = 90d. Total 150m wide fracture zone with multiple small fractures between. **Black silica in fractures and fossils, merging to black dolomite away from silica veins.** Mottled dolomite in fracture zone.

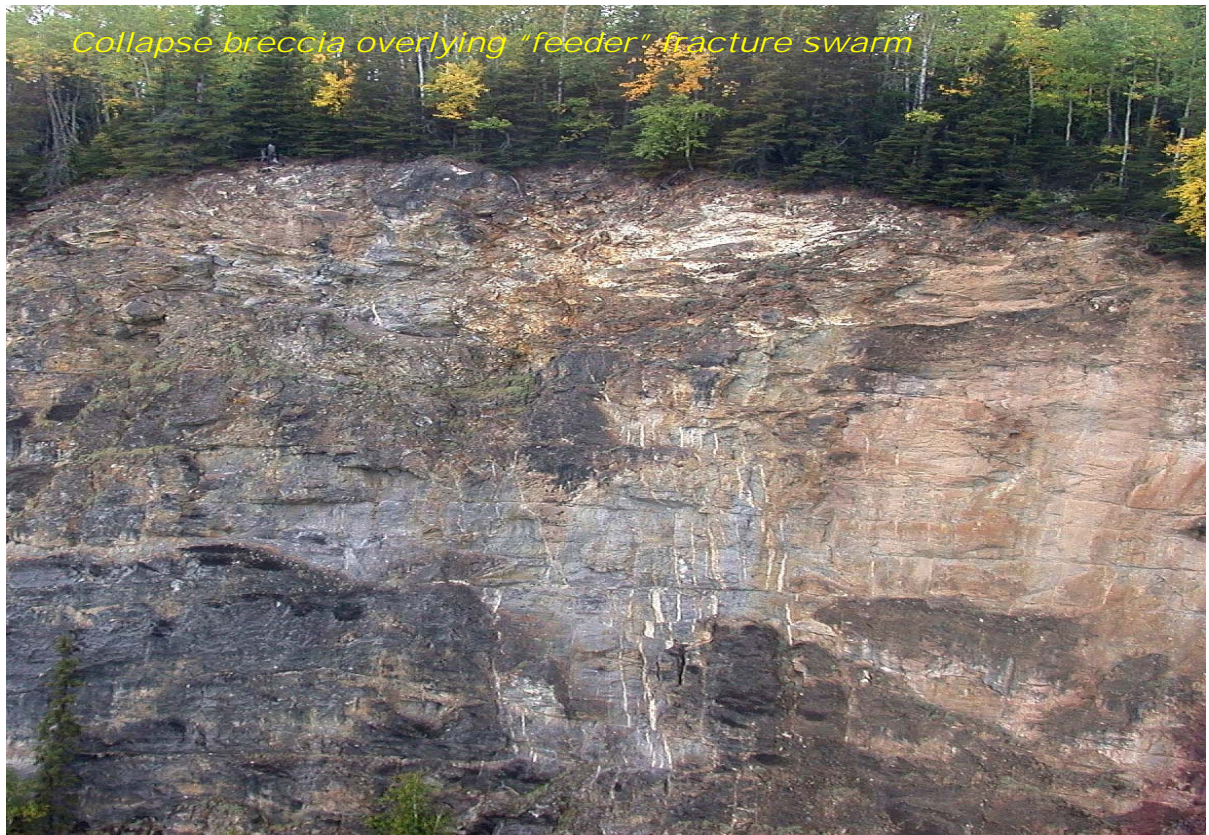
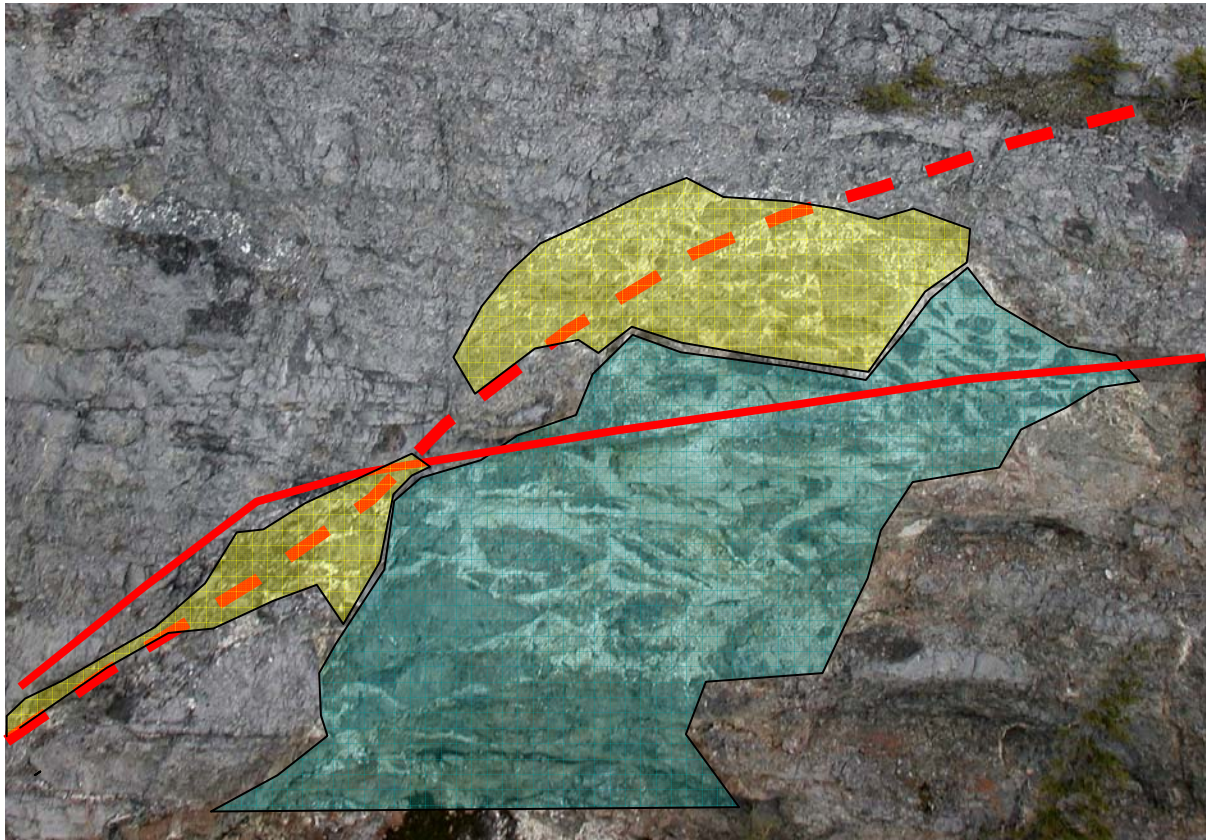
### **3. Nahanni Butte Fault & Breccia Detail**

A significant portion of the Butte's cliff-face is covered with slump debris so a clear picture of breccia distribution is not possible. In exposures there is a smattering of breccias across all zones, with most located within the uppermost Nahanni limestones. Breccia zones up to +/- 200m height and where sub-horizontal bedding-confined zones break upwards into overlying beds. Breccia zones commonly associated with faulting or severe fracturation.

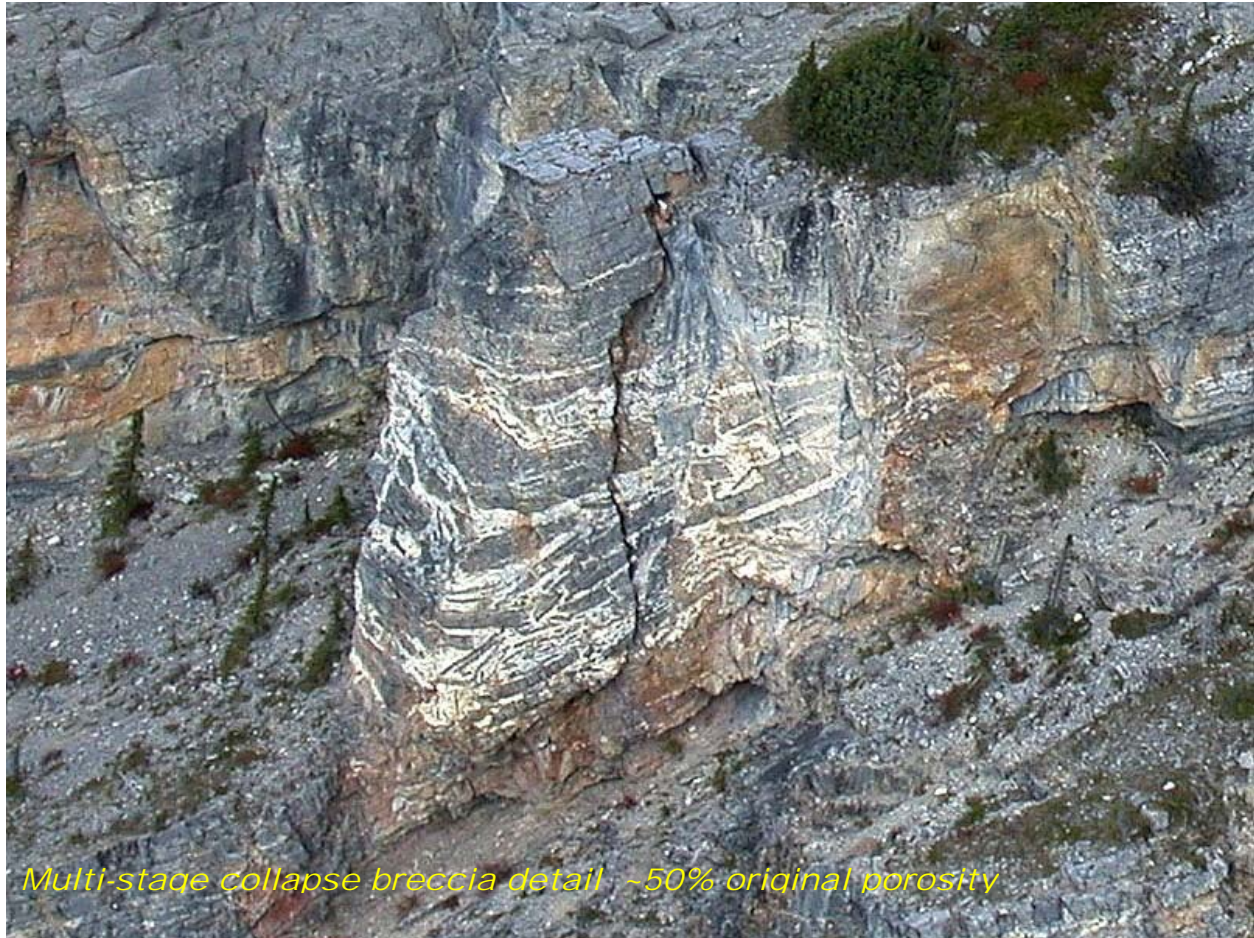
Zones appear to be predominately "grain-supported" host rock blocks in tectonically brecciated zones, occasionally with "collapse" features. White infill up to 25% breccia volume assumed to be large dolomite rhombs that are exposed on the ridge crest.

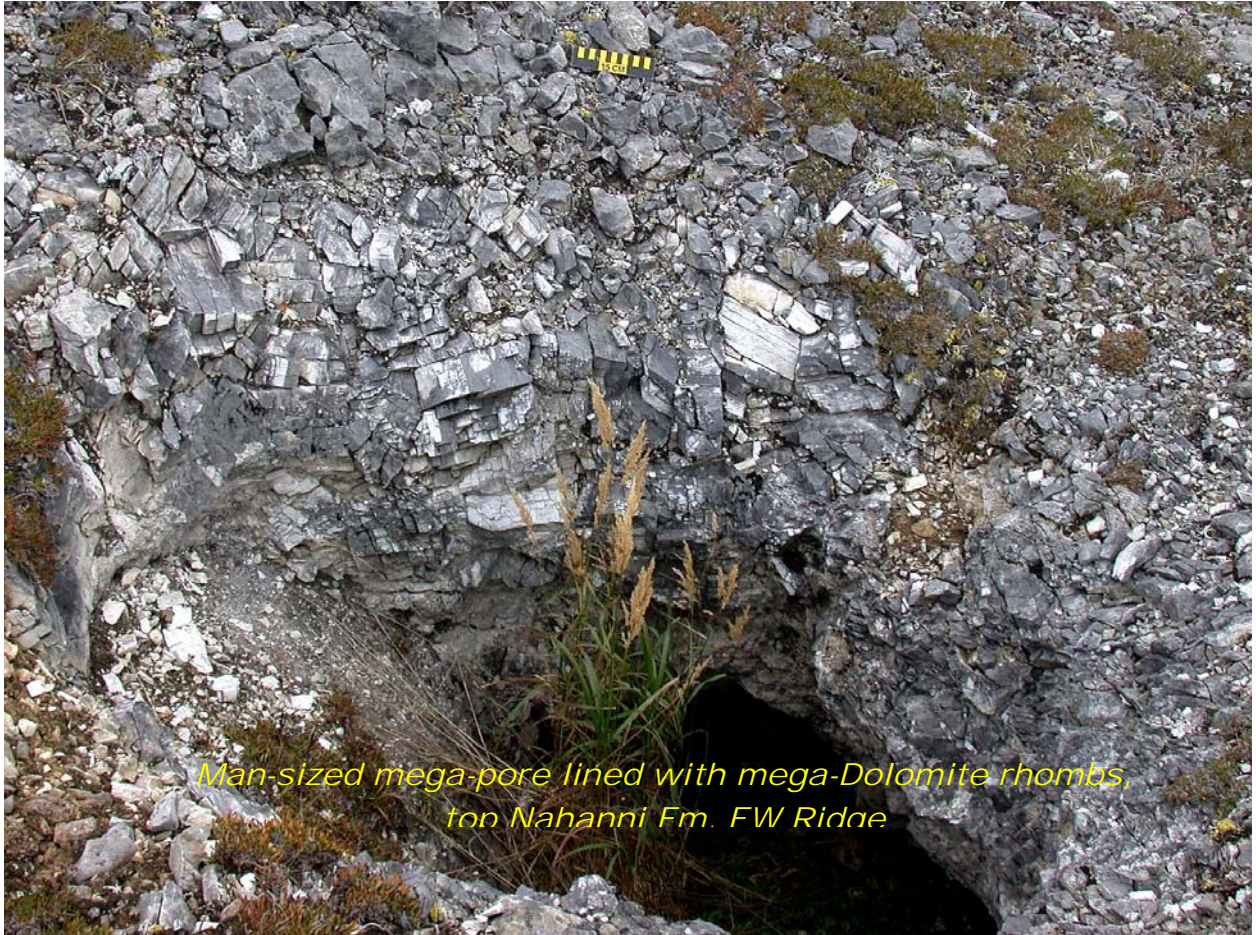
EW R SITE 7

**Dolomite “vent” in zone of collapse breccia, 9” wide vent with 3’ solid saddle dolomite walls and 3’ cave, 3m wide ls blocks in breccia plus massive saddle dolomite along ridge top above “quarry”. Silica fault zone on west edge quarry, Strike = 150.**

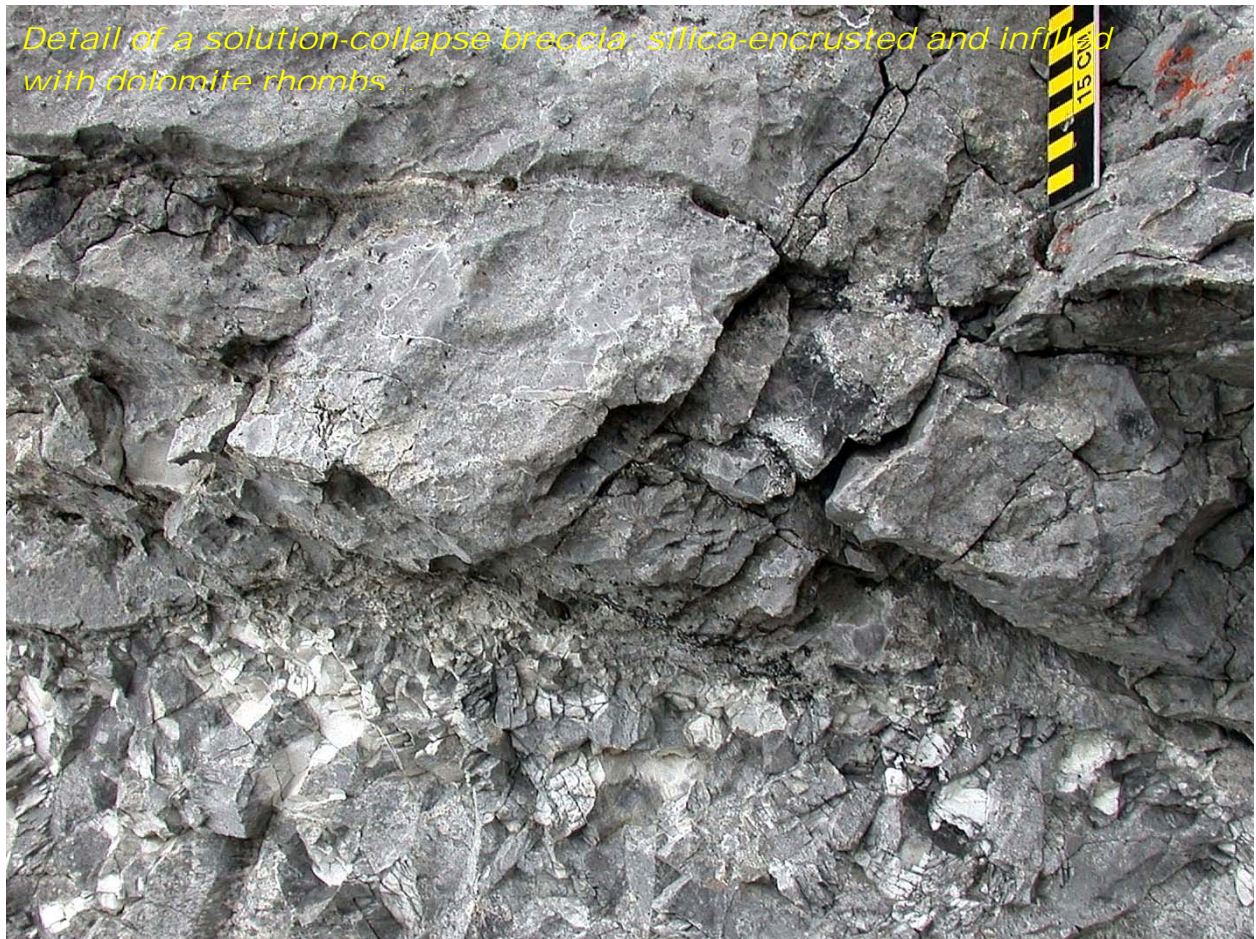
EW R SITE 8

West edge quarry walls part of massive collapse breccia. **Breccia consisting of ls and partially-dolomitized host rock blocks to several meters and massive large rhomb saddle dolomite in “matrix” and occasional silica “rind” blocks encased in breccia. Walls generally saddle dolomite with no silica rind.**

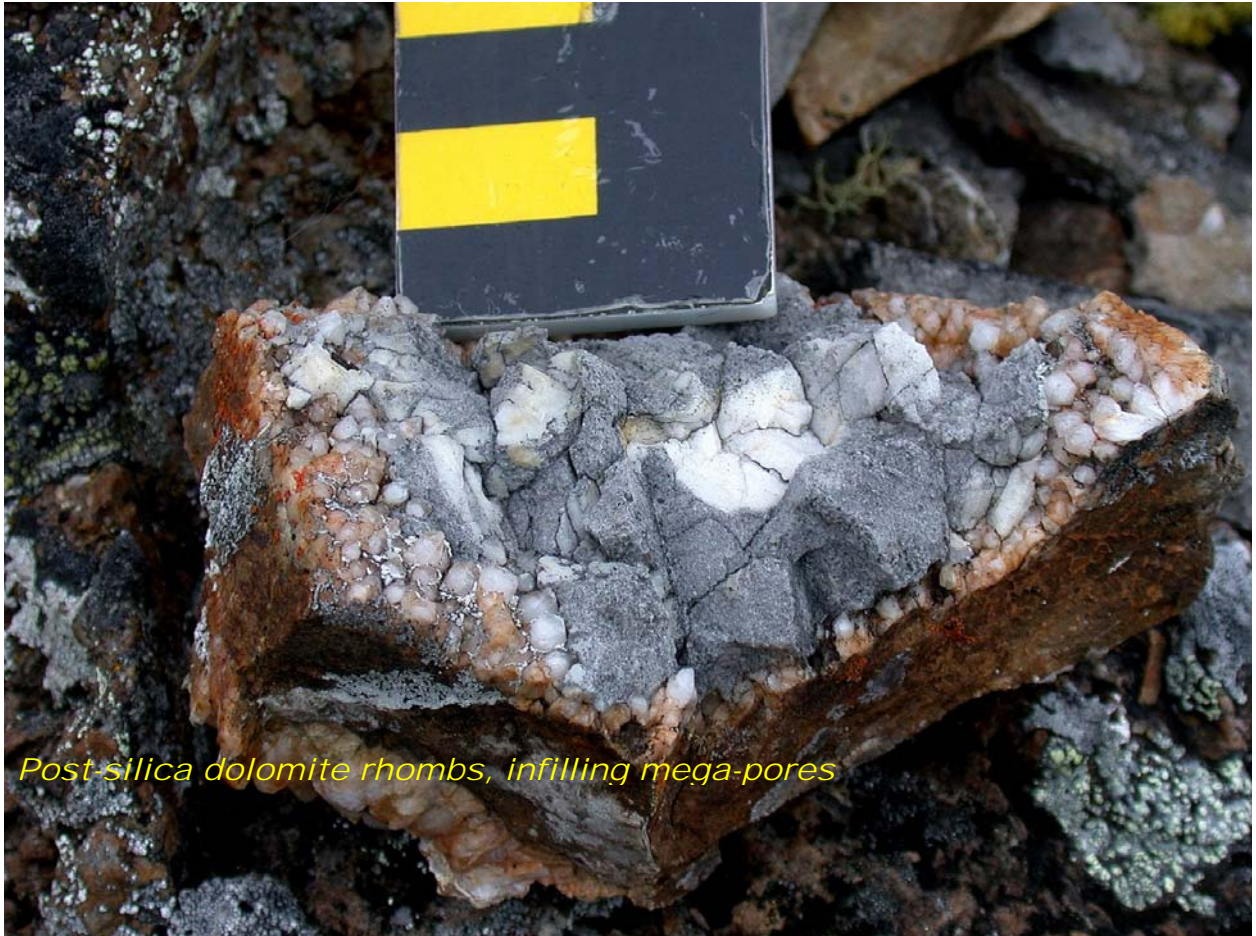
EWR SITE 24

**Continuous collapse breccia, transitional at western margin to a fracture breccia, but with occasional saddle dolomite still present. Saddle dolomite in outcrop to within 2m of silica fault swarm.**

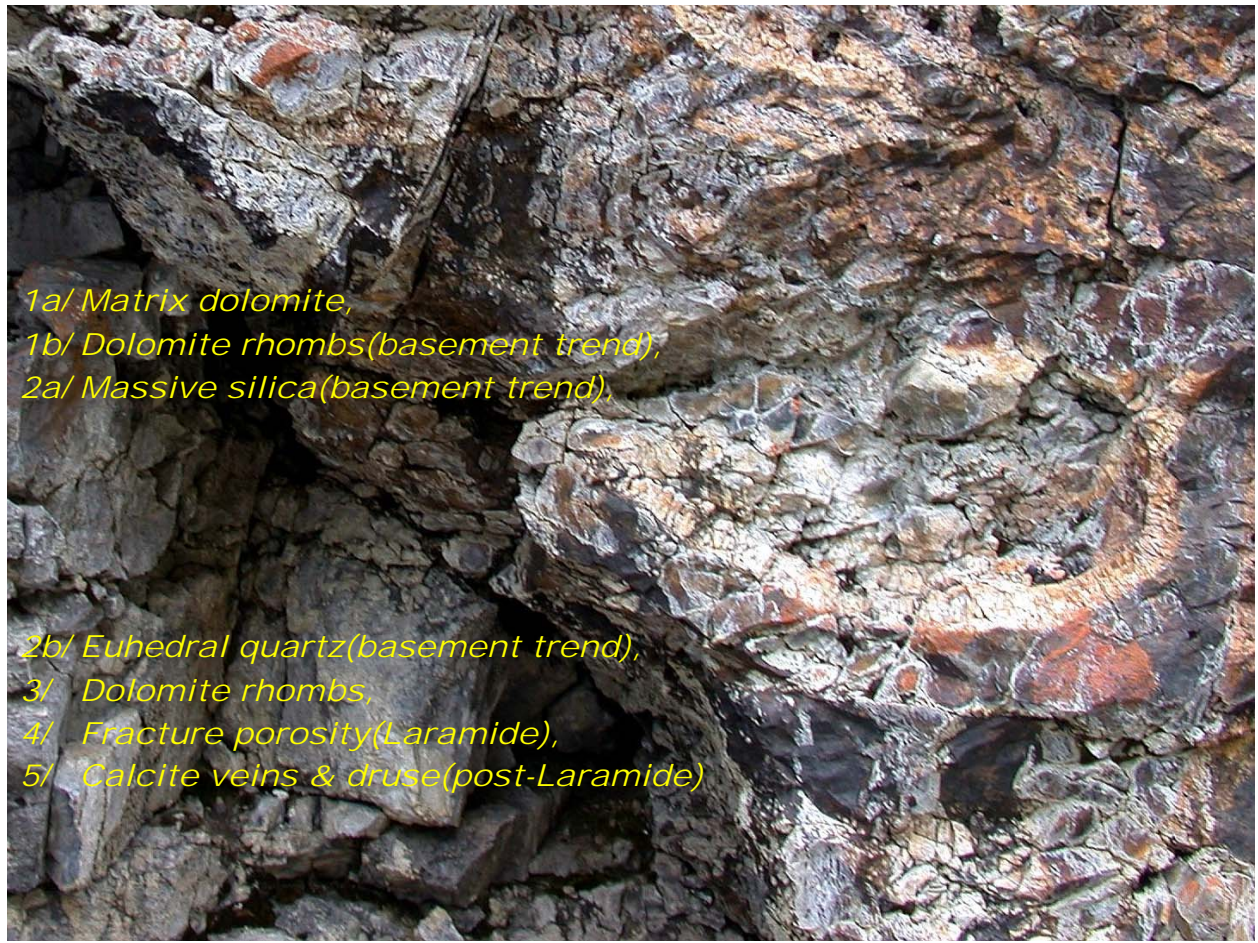
1a/ Matrix dolomite,

1b/ Dolomite rhombs(basement trend),

4/ Fracture porosity(Laramide),

5/ Calcite veins & druse(post-Laramide)

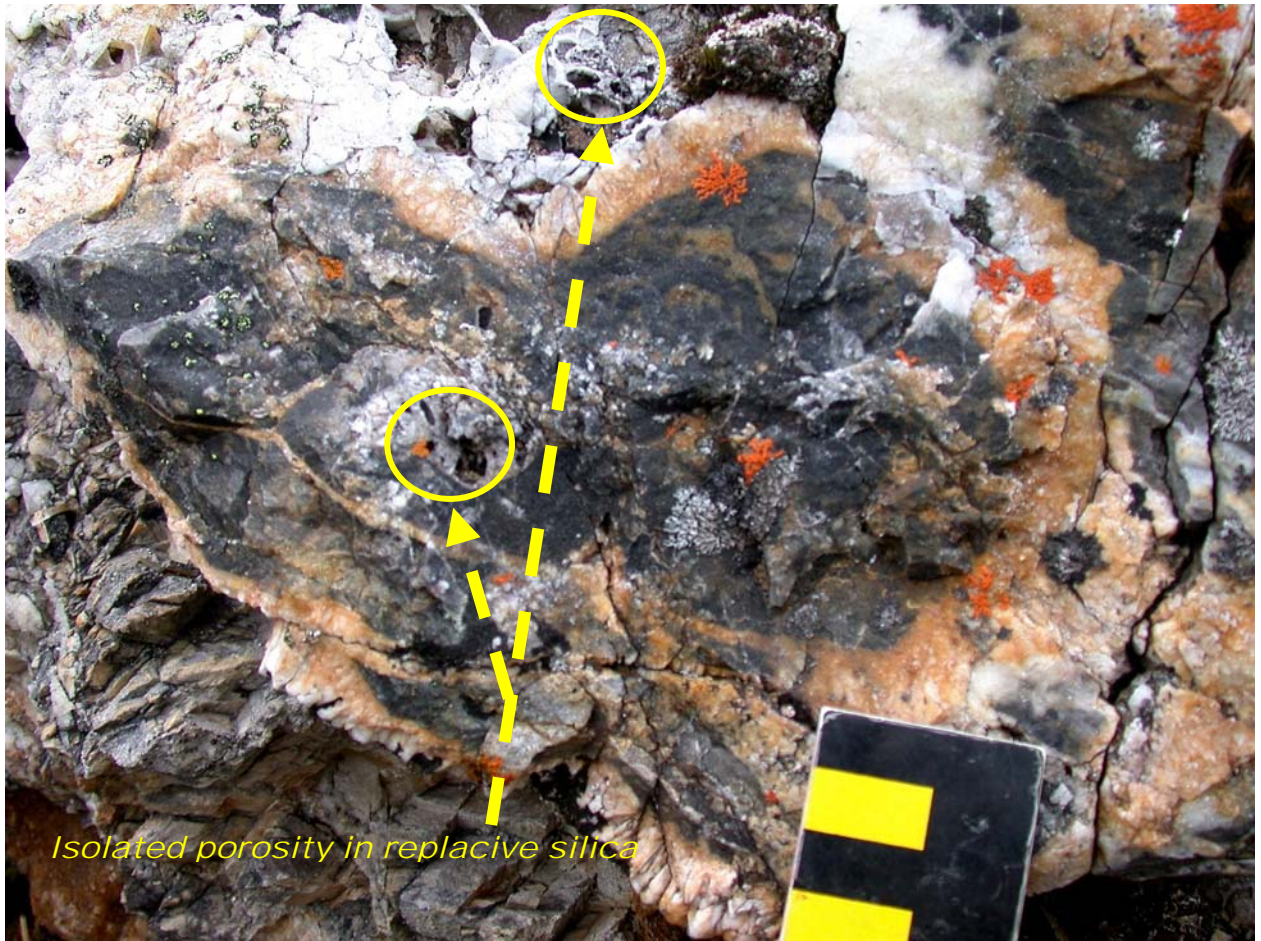
*Isolated porosity in replacive silica*
