FINAL TECHNICAL FIELD PROGRAM REPORT

Richardson Mountains Geological Field Excursion
July 19-23, 2004
(Approximately 68° 00' N; 135° 30' W)

ConocoPhillips Canada

Prepared by:
Dr. Gary Prost, P. Geol.
ConocoPhillips Canada

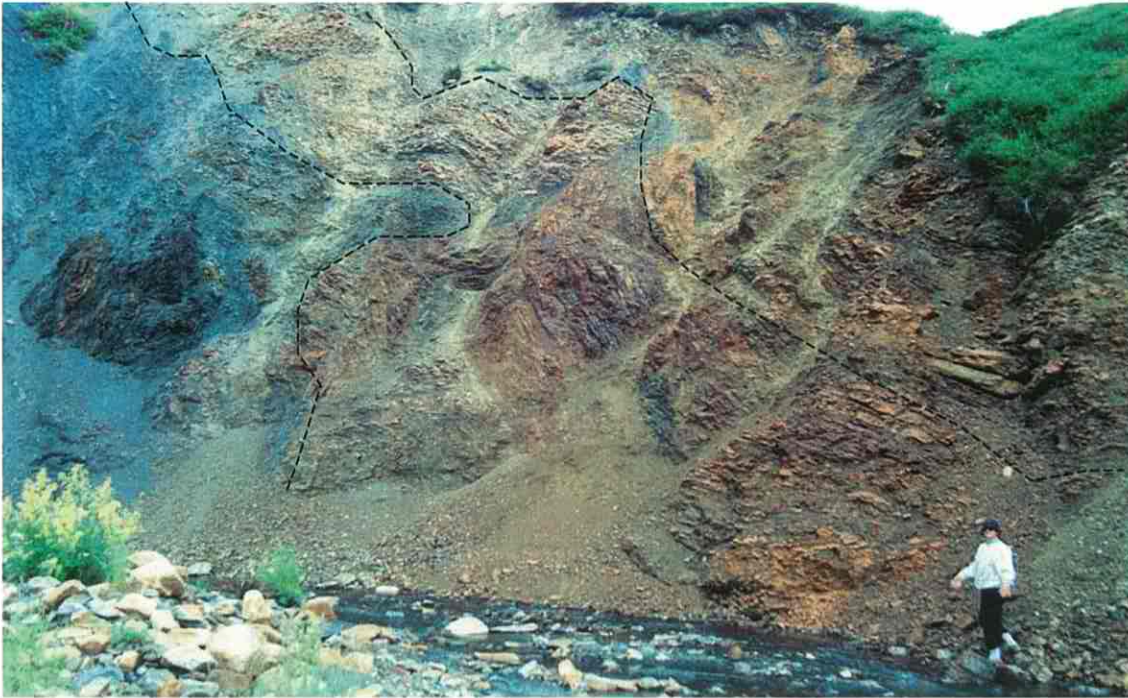
Figure 4: Mt. Goodenough Formation deformed within the Trevor fault zone.

The Trevor fault is a regional strike-slip fault with 20-50 kilometers of lateral offset and hundreds of meters of vertical throw. This was one of two seismic scale faults observed, and deformation is intense. The fault zone exposes up to 300 m of highly sheared and internally folded shales of the Arctic Red River and Mount Goodenough formations (Figure 4), and sheared and brecciated Kamik sandstone (Figure 5). Shale beds within the Kamik are tectonically thinned in places (Figure 6), and sandstones indicate bedding plane slip (Figure 7) as well as intense, apparently randomly oriented shear surfaces. In one case a brecciated pod of sandstone is entirely encased within shales (Figure 8).

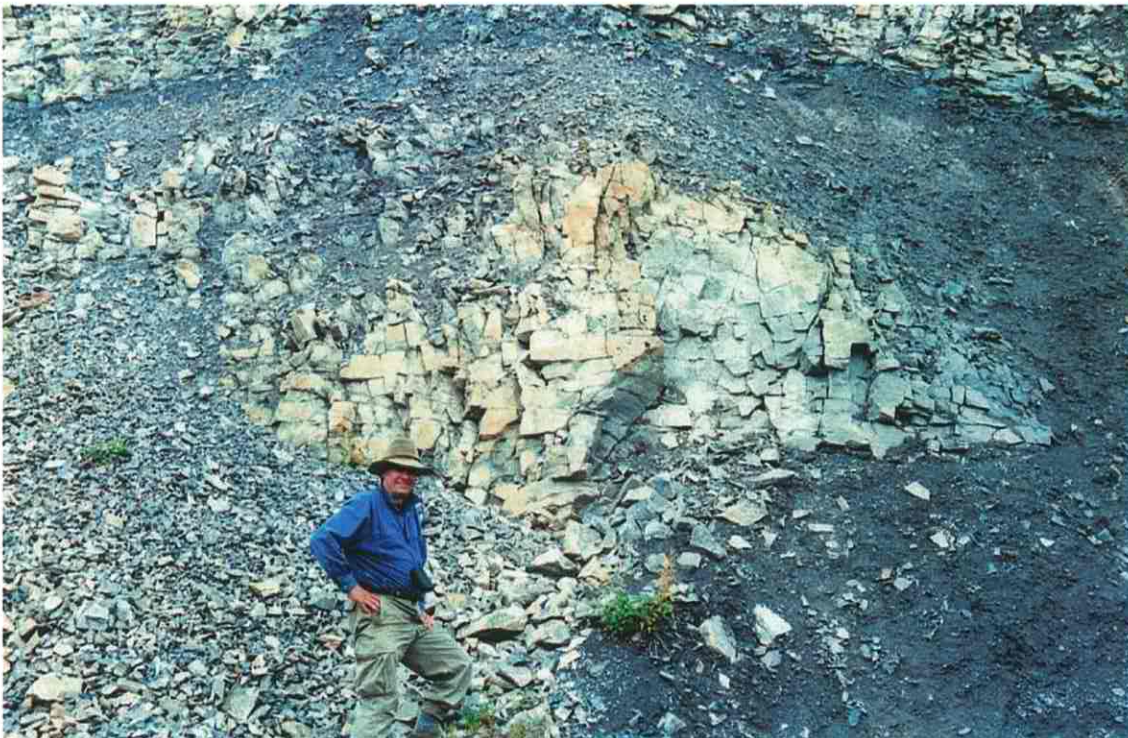
Figure 5: Brecciated Kamik Formation sandstone in the Trevor fault zone.

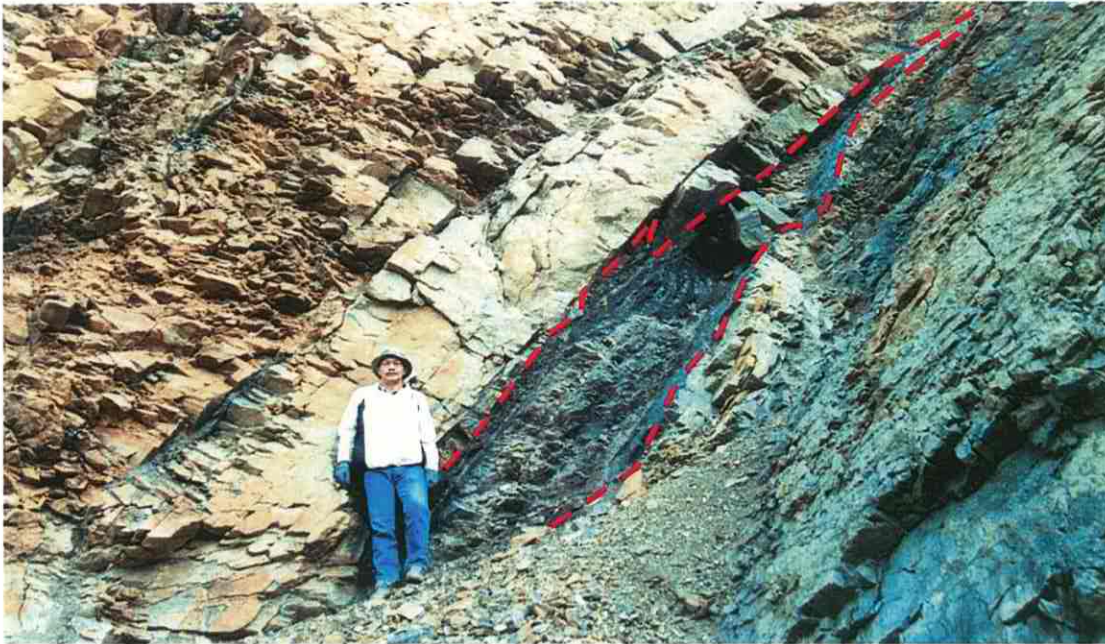
Figure 6: Tectonically thinned Kamik shale interbed, Trevor fault zone.

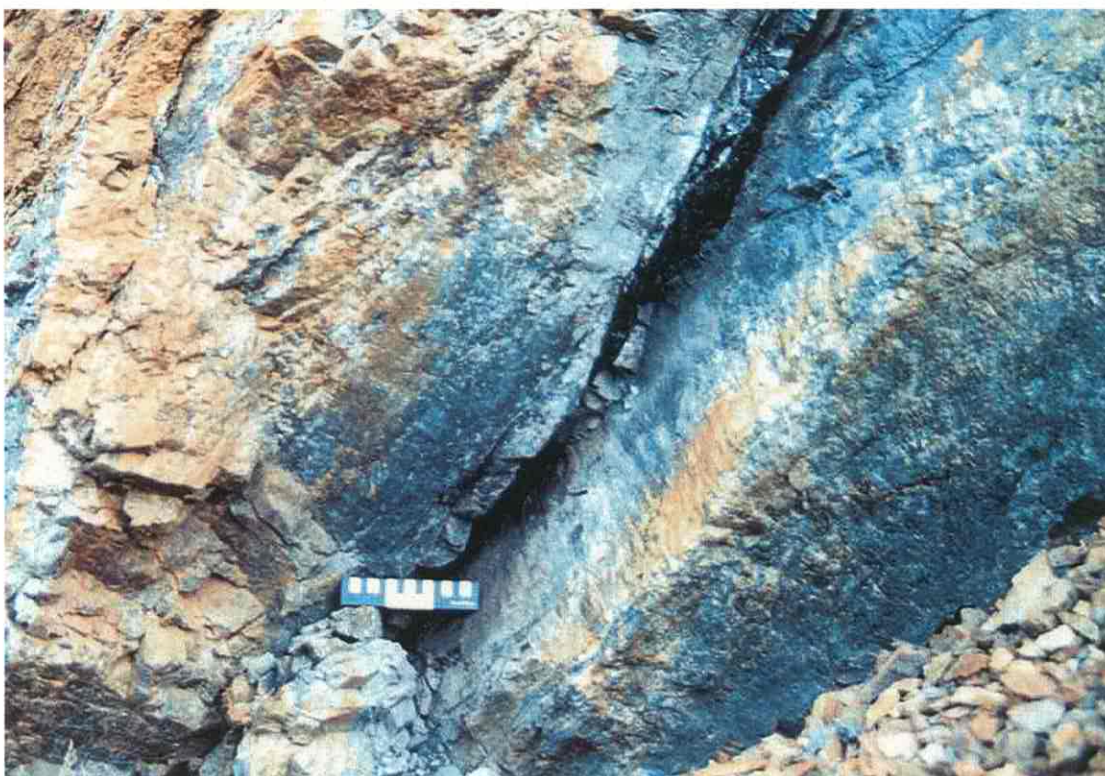
Figure 7: Slickensides indicate bedding plane slip within the Kamik along the Trevor fault zone.

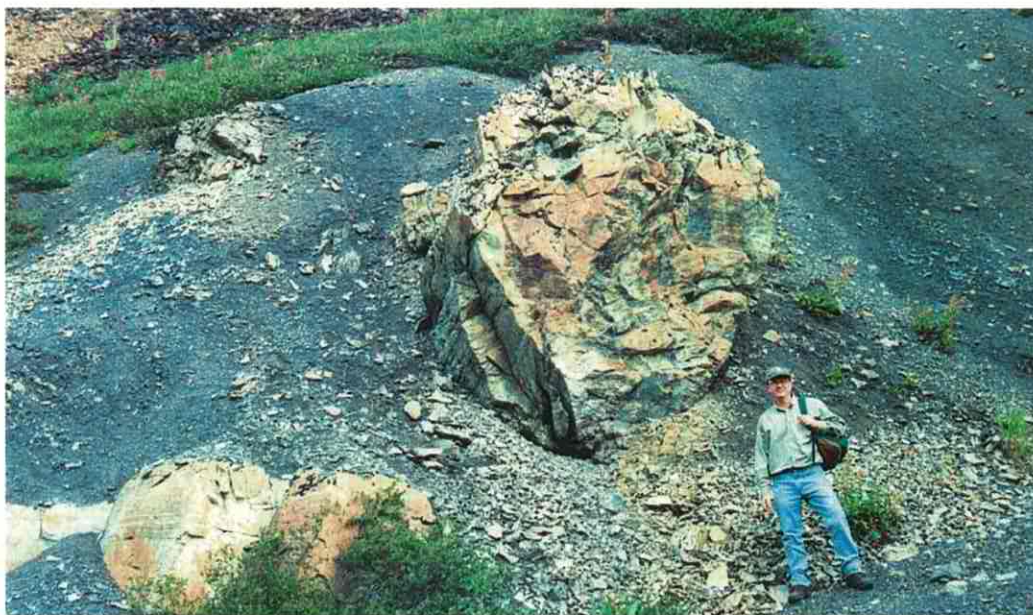
Figure 8: Pod of pervasively sheared Kamik sandstone within shales along the Trevor fault zone.

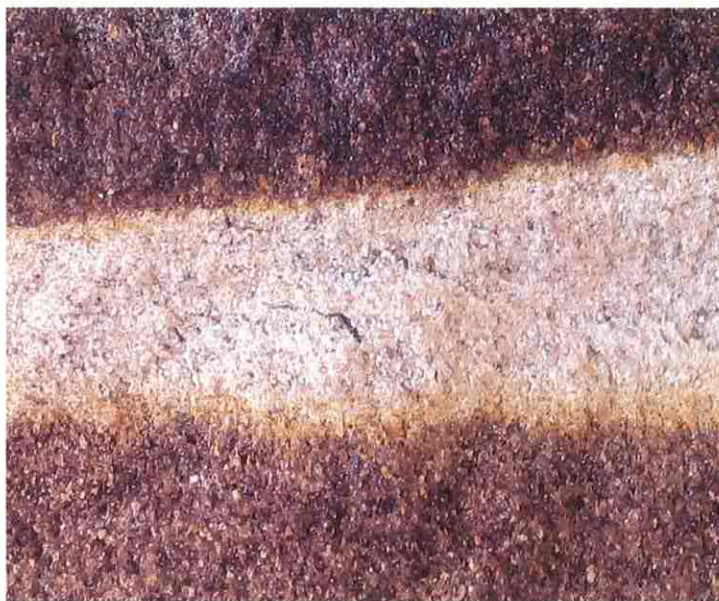
Figure 12: Detail of deformation band in Kamik C sandstone showing decreased porosity within the deformation band (white zone).

A normal fault in Martin Creek valley has about 10 m offset across a 15 m wide zone. The fault zone in the footwall (upthrown side) consists of 2 m of discrete fault planes, and deformation bands in the Kamik C sandstone (Figures 10, 11, 12). Mercury injection work has been performed on the deformation bands to determine permeability relative to undeformed Kamik. Pervasive fault-parallel shear fabric can be seen in the hanging wall Mt. Goodenough Formation (Figure 13). This suggests that the fault would act as a baffle to flow across the fault (Figure 14).

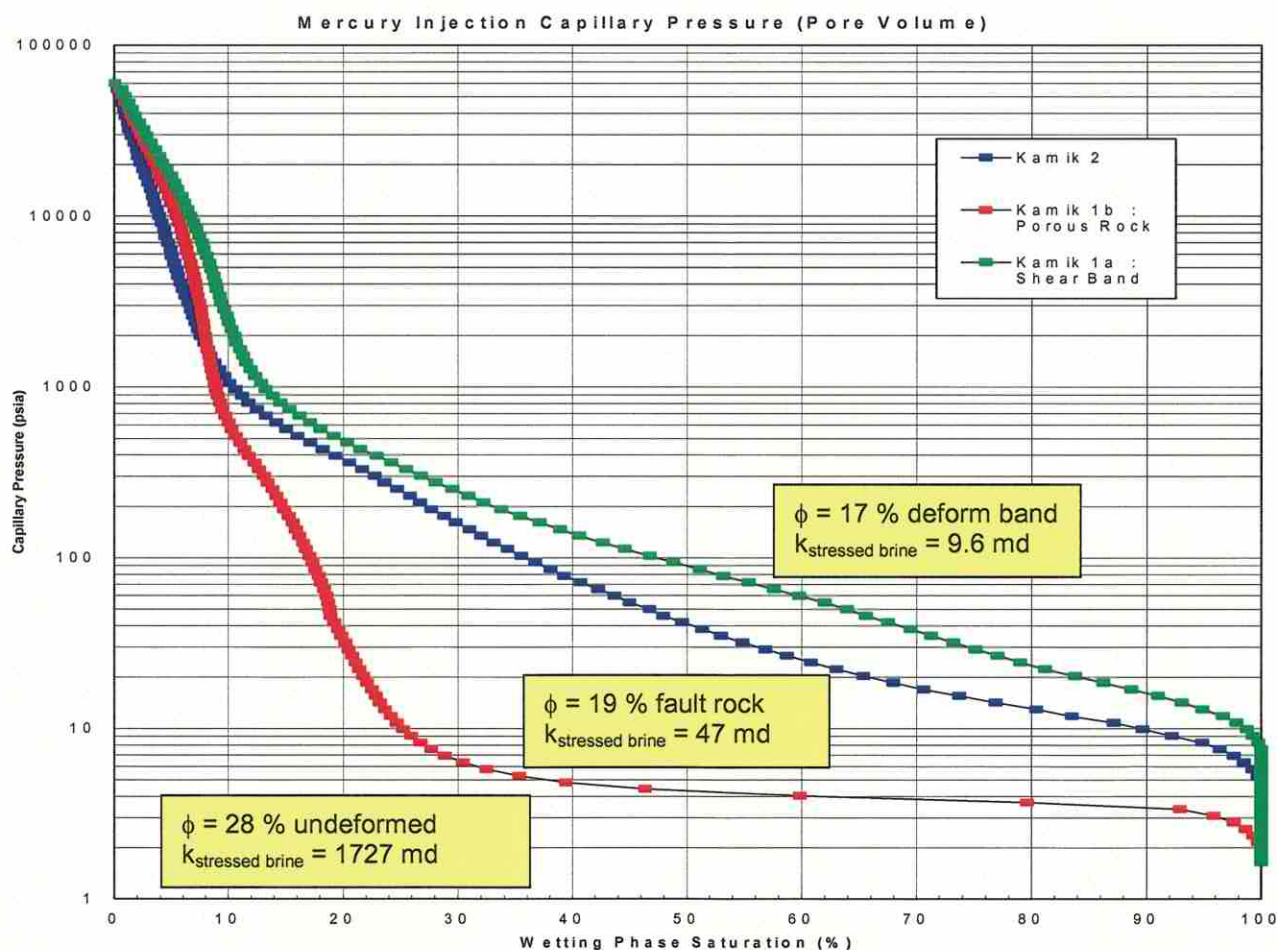
Figure 14: Capillary pressure work shows a two order of magnitude decrease in permeability from undeformed rock to deformation bands seen in Figures 11, 12.

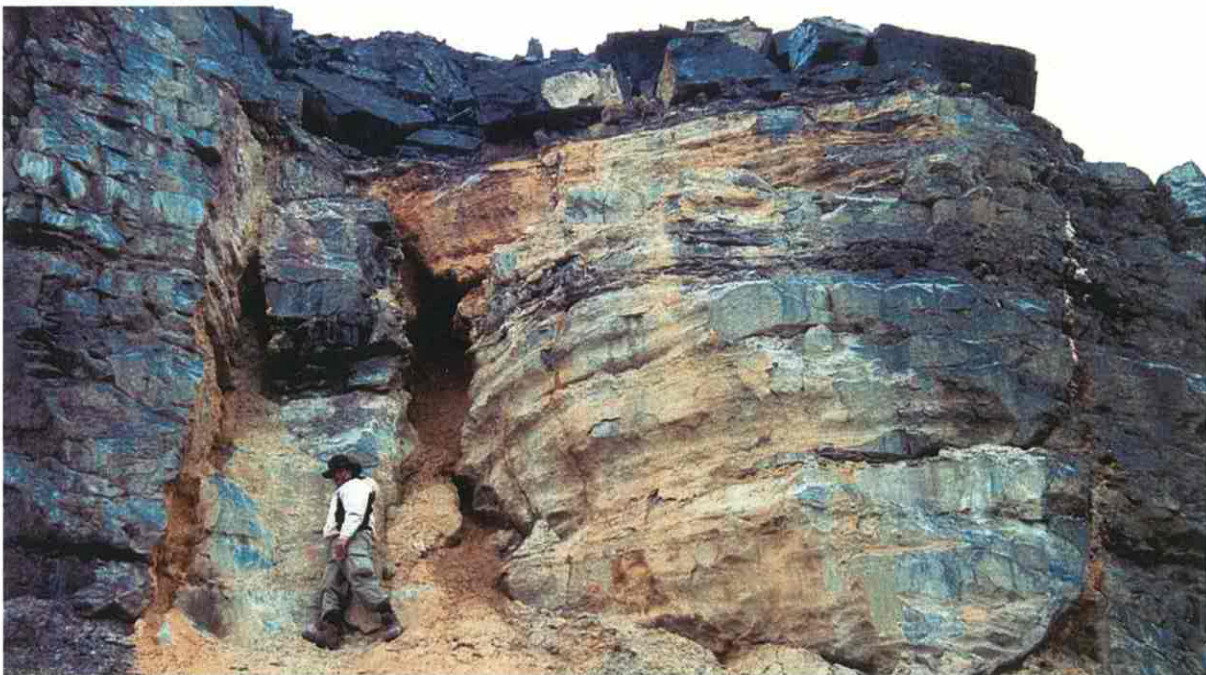
Figure 20: Karst developed along joints, Devonian limestone in South Campbell Lake quarry. Karst is filled with rusty clay material.

The black limestone at both quarries contains fractures and karsts developed along fractures (Figures 20, 21). Some fractures are filled with calcite and some are open. Spacing ranges from 1 m to over 10 m in a given set. At least two sets exist at 30 and 60 degrees to each other. Karsts are filled with clay, brecciated limestone, and siltstone. Karst features are 2 to 5 m wide and are reported to contain Cretaceous fossils.

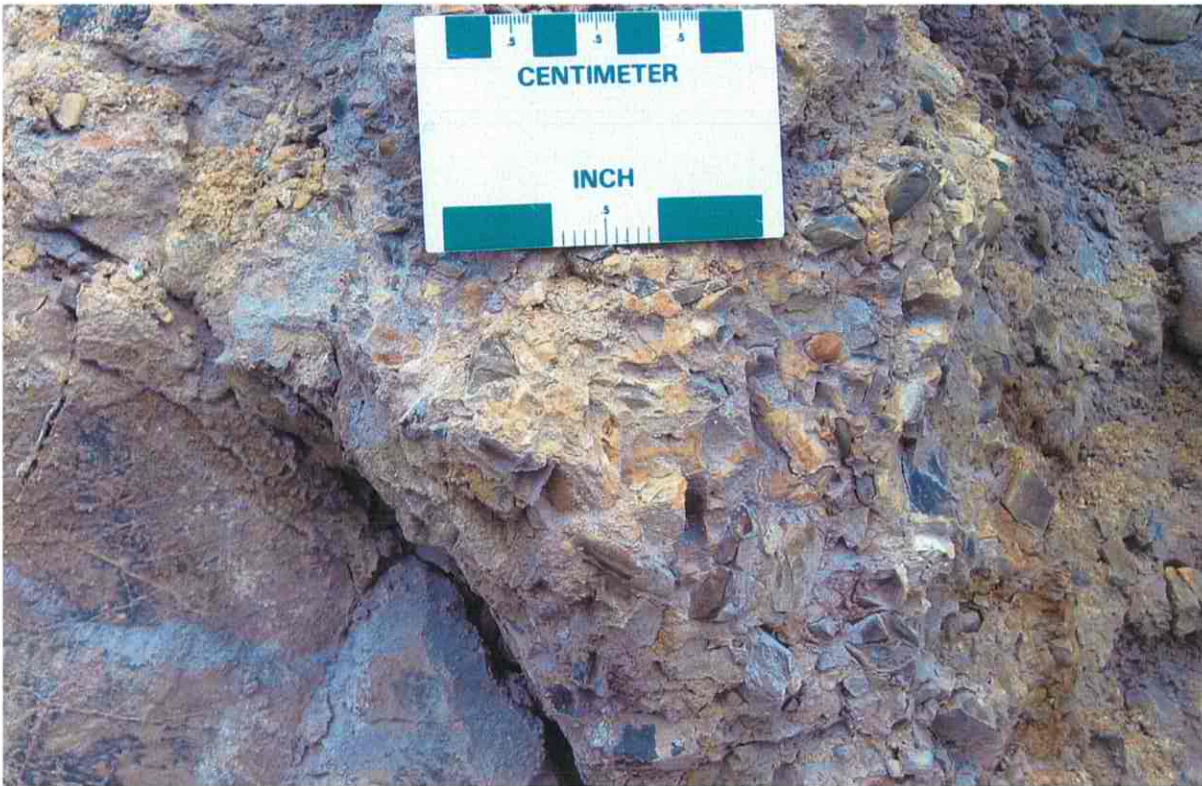
Figure 21: Karst fill at South Campbell Lake quarry. Fill consists of limestone and siltstone breccia, and is reported to contain Cretaceous fossils.

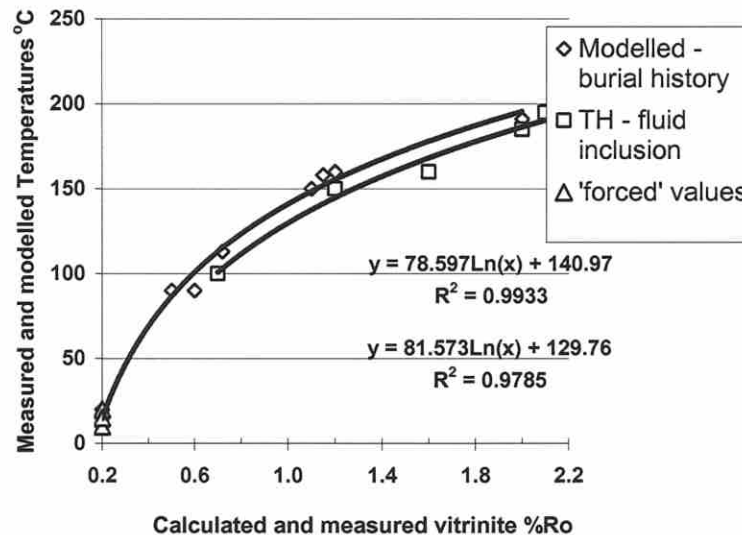
Figure 1. Correlation between %Ro vitrinite and temperature established for Mannville Formation coals, WCSB.

Based on correlations done between temperature (established from fluid inclusion work and/or modeling) and vitrinite %Ro for lower Cretaceous coals in the Mannville of Alberta portion of the WCSB (Fig. 1), maximum temperatures for the Martin Creek and Trevor fault zone coals were possibly on the order of 90-95 °C and 125-130 °C, respectively.
