SEISMOGRAPH SURVEY

COLVILLE LAKE AREA, N.W.T.

ASHLAND OIL CANADA LTD.

PROJECT NO 52-6-6-73-1

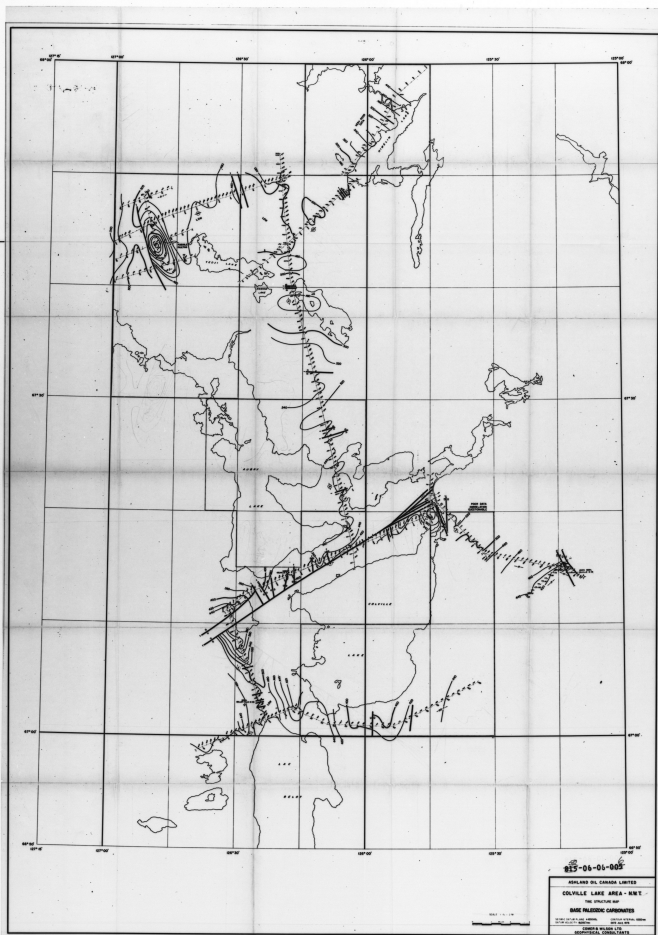
1. Time Structure Map - Base Paleozoic Carbonates
2. Time Structure Map - Precambrian
3. Isochron Map - Base Paleozoic Carbonates to Precambrian

The isochron map over this structure shows approximately 0.035 secs. thinning. There are two possible geological explanations:

1. The structural deformation has taken place post-Devonian, causing the salt to be squeezed out of the Cambrian section over the structure.
2. The Paleozoic section is draped over an existing basement high.

The remainder of the isochron map is featureless except for some variations on the most southerly line.
