GENERAL GEOLOGY  
&  
FRACTURE ANALYSIS SURVEY

P. & N. G. PERMIT NO. 4570

CHERMARC DEVELOPMENTS LTD.

RAYALTA PETROLEUMS LTD.

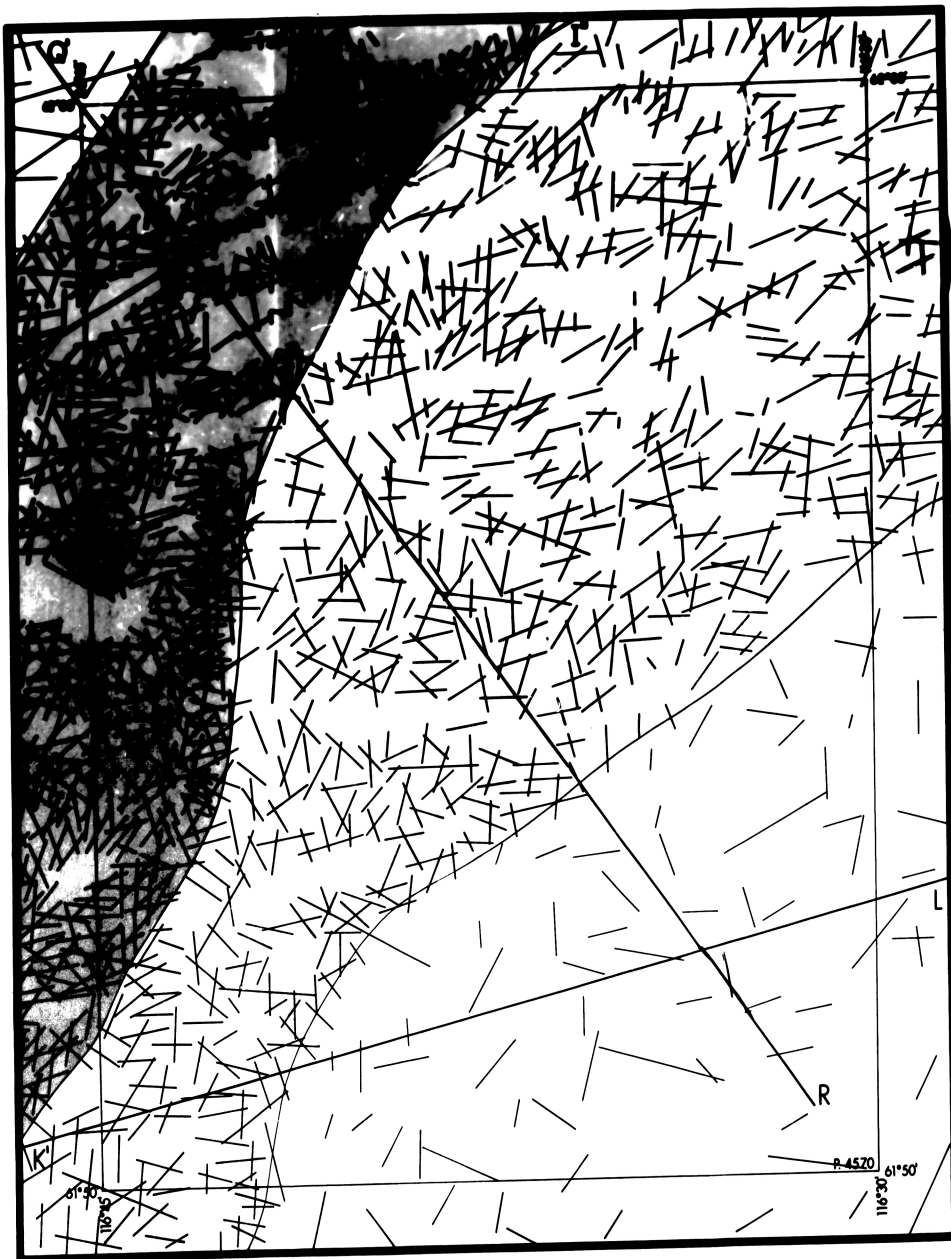
TOTAL FRACTURE PATTERN

Reference to the Total Fracture Pattern Map which accompanies this report will show that there is one area of "high" fracture intensity, and one area of "low" fracture intensity (green). The general interpretation is that the low fracture intensity areas are underlain by topographic highs on the Basement. With this established, the deduction is that the Basement is high in the southeast corner of Permit No. 4570.

Fractures as plotted on the mosaic show considerable variation in intensity. There is one area where the fracture intensity is greater than normal and there is one area where the fracture intensity is less than normal. The high intensity area is shown in red and the low intensity area is shown in green.

causes them. The low intensity area on Permit No. 4570 is located in the southeast corner of the Permit and it is difficult to estimate the size of the causative feature.
